# Access Compliance Report

## Public Rights-of-Way

### (Curb Ramps)

Intersection ID: 13708	Main Street: WEST_BV	Cross Street: WICKFORD_PL	Location: NE
ADA ID: 02E6E5BCCD93	Ramp Type: Perp	Initial Pass/Fail: Fail	Overall Compliance: No
Severity Score: 12.5			
Codes/Mitigation Info/Possible Solution		Field Measurements/Component Compliance

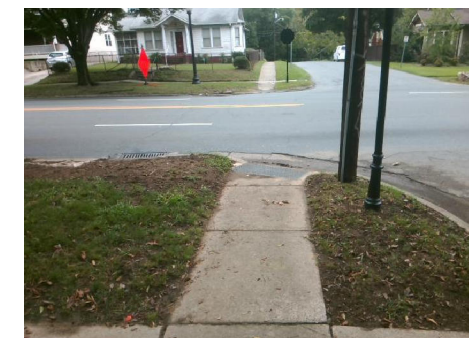
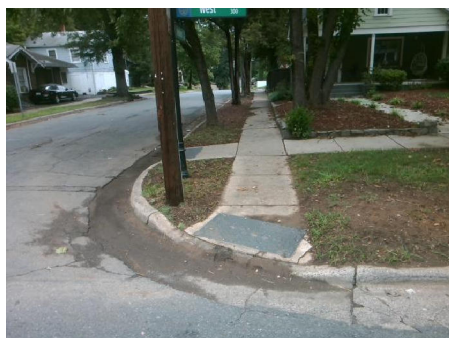
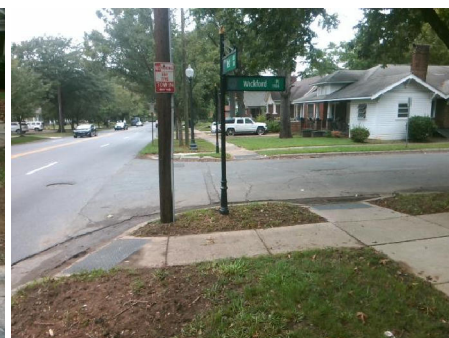
**Not Found, R304.2.2**

Compliance	Description	Data	Compliance	Description	Data
N/A	Ramp Length (in)	50.0	No	Ramp Slope (%)	8.8
Yes	Ramp Width (in)	48.0	Yes	Ramp XSlope (%)	1.1
N/A	Flare Type LT	N/A	N/A	Flare Type RT	N/A
N/A	Flare Slope LT (%)	N/A	N/A	Flare Slope RT (%)	N/A
N/A	Flare Traversable LT?	N/A	N/A	Flare Traversable RT?	N/A
N/A	Landing Length (in)	N/A	N/A	DWS Provided?	N/A
N/A	Landing Width (in)	N/A	N/A	DWS Contrast?	N/A
N/A	Landing Slope (%)	N/A	N/A	DWS Length (in)	N/A
N/A	Landing X Slope (%)	N/A	N/A	DWS Full Width?	N/A
N/A	Landing Curb? (Y/N)	N/A	N/A	DWS Offset (in)	N/A
N/A	Shared Landing?	N/A			
N/A	Gutter Ponding?	N/A	N/A	Gutter Slope (%)	N/A
N/A	Gutter Lip Ht (in)	N/A	N/A	Gutter X Slope (%)	N/A
N/A	Painted X Walk1?	No	N/A	Painted X Walk2?	N/A
	X Walk 1 Direction	To SW		X Walk 2 Direction	N/A
N/A	X Walk 1 Width (in)	N/A	N/A	X Walk 2 Width (in)	N/A
	X Walk 1 Slope (%)	4.8		X Walk 2 Slope (%)	N/A
	X Walk 1 X Slope (%)	0.7		X Walk 2 X Slope (%)	N/A

**Remove & Replace Entire Ramp.**

Total Cost: \$ 1850.00
