Access Compliance Report

Public Rights-of-Way

(Curb Ramps)

Intersection ID: 27177	Main Street: PROVIDENCE_RD	Cross Street: MCKEE_RD	Location: SE
ADA ID: 02E78CBB474F	Ramp Type: Perp	Initial Pass/Fail: Pass	Overall Compliance: No
		Severity Score: 10

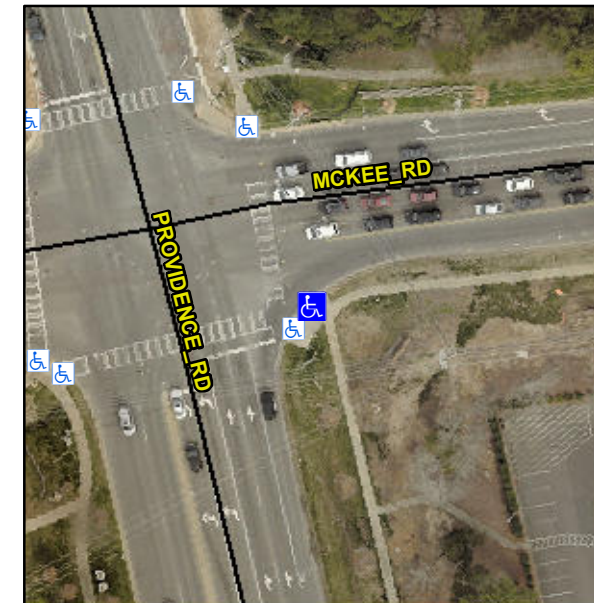
Not Found, R304.2.2-Perp, R304.3.2-Para, R305

Compliance	Description	Data	Compliance	Description	Data
N/A	Ramp Length (in)	108.0	Yes	Ramp Slope (%)	7.3
Yes	Ramp Width (in)	53.0	Yes	Ramp XSlope (%)	0.2
N/A	Flare Type LT	Sloped	N/A	Flare Type RT	N/A
N/A	Flare Slope LT (%)	7.0	Yes	Flare Slope RT (%)	7.6
N/A	Flare Traversable LT?	Yes	N/A	Flare Traversable RT?	Yes
Yes	Landing Length (in)	71.0	No	DWS Provided?	No
Yes	Landing Width (in)	54.0	N/A	DWS Contrast?	No
No	Landing Slope (%)	2.8	N/A	DWS Length (in)	N/A
Yes	Landing X Slope (%)	1.9	N/A	DWS Full Width?	No
N/A	Landing Curb? (Y/N)	No	N/A	DWS Offset (in)	N/A
N/A	Shared Landing?	No			
Yes	Gutter Ponding?	No	Yes	Gutter Slope (%)	4.1
Yes	Gutter Lip Ht (in)	0.0	Yes	Gutter X Slope (%)	0.2
N/A	Painted X Walk1?	Yes	N/A	Painted X Walk2?	N/A
	X Walk 1 Direction	To N		X Walk 2 Direction	N/A
N/A	X Walk 1 Width (in)	120.0	N/A	X Walk 2 Width (in)	N/A
	X Walk 1 Slope (%)	2.7		X Walk 2 Slope (%)	N/A
	X Walk 1 X Slope (%)	1.7		X Walk 2 X Slope (%)	N/A

Yes	Ramp inside XWalk1?	Yes	N/A	Ramp inside XWalk2?	N/A
	Road Slope (%)	N/A	N/A	Clear Space?	Yes
	Road X Slope (%)	N/A	N/A	Clear Space to XWalk (in)	N/A
Yes	Any Obstructions?	No	Yes	Storm Grate/Utility Hazard?	No
	Obstruction Type			Storm Grate/Utility Type	
		N/A			N/A
			Yes	Surface Condition? (G/P)	Good

Possible Solutions:

Remove & Replace Entire Ramp.

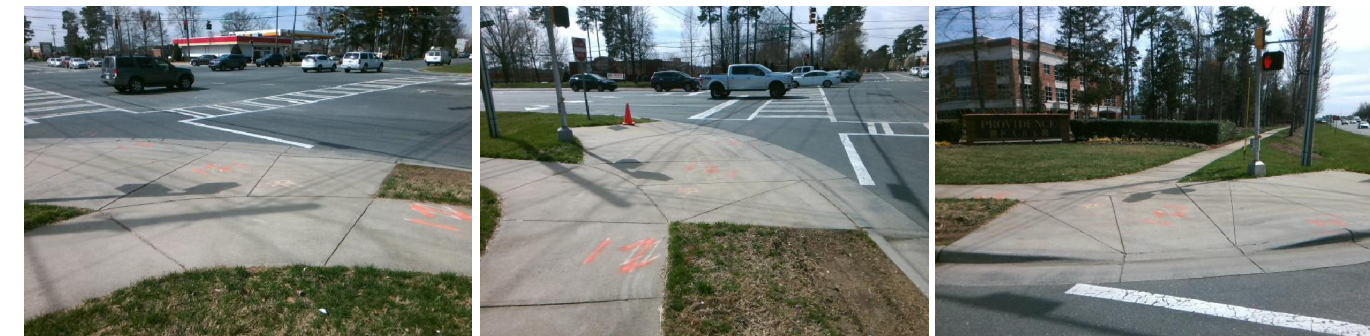
Street 1 Name	MCKEE RD
Stop Condition-Street 2	Signal
Street 2 Name	N/A
Stop Condition-Street 1	N/A
