Access Compliance Report

Public Rights-of-Way

(Curb Ramps)

Intersection ID: N/A	Main Street: CANTERBURY_CASTLE_DR	Cross Street: BELVEDERE_CASTLE_DR	Location: NW
ADA ID: 02E9C81F330D	Ramp Type: Perp	Initial Pass/Fail: Fail	Overall Compliance: No
Severity Score: 21.25			
Codes/Mitigation Info/Possible Solution		Field Measurements/Component Compliance

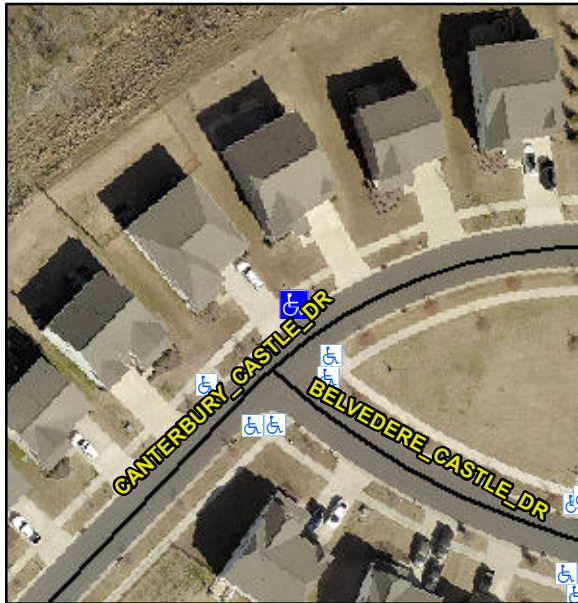
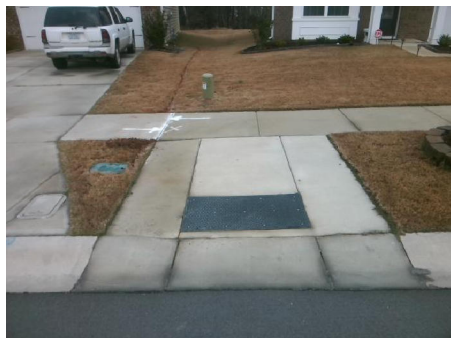
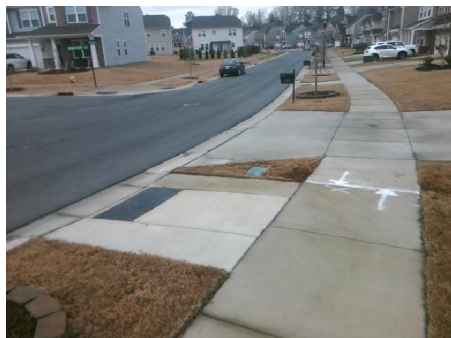
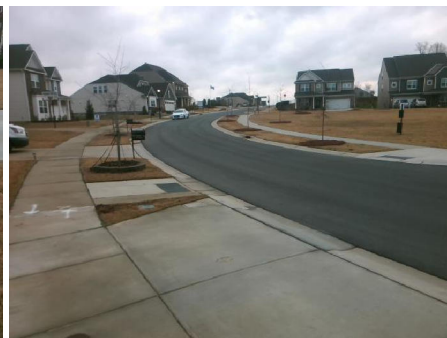
Not Found, R304.5.1, R304.5.3

Compliance	Description	Data	Compliance	Description	Data
N/A	Ramp Length (in)	94.0	Yes	Ramp Slope (%)	6.6
No	Ramp Width (in)	46.0	No	Ramp XSlope (%)	6.0
N/A	Flare Type LT	N/A	N/A	Flare Type RT	N/A
N/A	Flare Slope LT (%)	N/A	N/A	Flare Slope RT (%)	N/A
N/A	Flare Traversable LT?	N/A	N/A	Flare Traversable RT?	N/A
N/A	Landing Length (in)	N/A	N/A	DWS Provided?	N/A
N/A	Landing Width (in)	N/A	N/A	DWS Contrast?	N/A
N/A	Landing Slope (%)	N/A	N/A	DWS Length (in)	N/A
N/A	Landing X Slope (%)	N/A	N/A	DWS Full Width?	N/A
N/A	Landing Curb? (Y/N)	N/A	N/A	DWS Offset (in)	N/A
N/A	Shared Landing?	N/A			
N/A	Gutter Ponding?	N/A	N/A	Gutter Slope (%)	N/A
N/A	Gutter Lip Ht (in)	N/A	N/A	Gutter X Slope (%)	N/A
N/A	Painted X Walk1?	No	N/A	Painted X Walk2?	N/A
	X Walk 1 Direction	To SE		X Walk 2 Direction	N/A
N/A	X Walk 1 Width (in)	N/A	N/A	X Walk 2 Width (in)	N/A
	X Walk 1 Slope (%)	4.8		X Walk 2 Slope (%)	N/A
	X Walk 1 X Slope (%)	1.1		X Walk 2 X Slope (%)	N/A

N/A	Ramp inside XWalk1?	N/A	N/A	Ramp inside XWalk2?	N/A
	Road Slope (%)	N/A	N/A	Clear Space?	N/A
	Road X Slope (%)	N/A	N/A	Clear Space to XWalk (in)	N/A
N/A	Any Obstructions?	N/A	N/A	Storm Grate/Utility Hazard?	N/A
	Obstruction Type			Storm Grate/Utility Type	
		N/A			N/A
			Yes	Surface Condition? (G/P)	Good

Remove & Replace Entire Ramp.

Total Cost: \$ 1850.00
