Access Compliance Report

Public Rights-of-Way

(Curb Ramps)

Intersection ID: 10034320	Main Street: PERIMETER_PY	Cross Street: N/A	Location: SW
ADA ID: 02FB3F40A6AE	Ramp Type: Perp	Initial Pass/Fail: Fail	Overall Compliance: No
Severity Score: 22.5			
Codes/Mitigation Info/Possible Solution		Field Measurements/Component Compliance

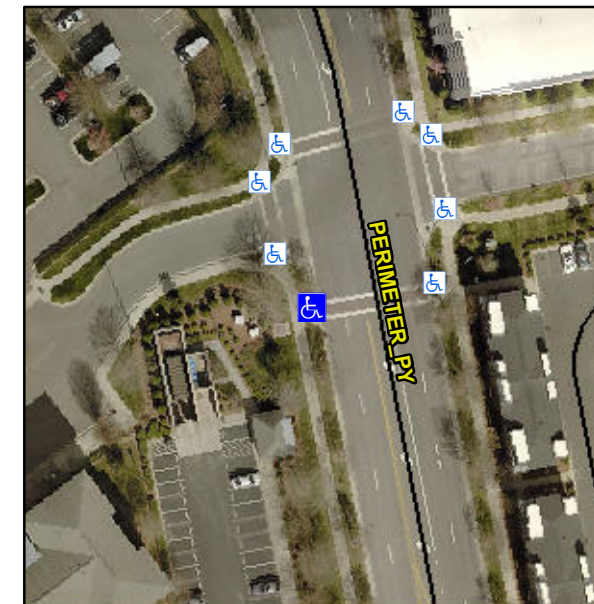
Compliance	Description	Data	Compliance	Description	Data
N/A	Ramp Length (in)	94.0	No	Ramp Slope (%)	10.3
No	Ramp Width (in)	46.5	No	Ramp XSlope (%)	2.3
N/A	Flare Type LT	N/A	N/A	Flare Type RT	N/A
N/A	Flare Slope LT (%)	N/A	N/A	Flare Slope RT (%)	N/A
N/A	Flare Traversable LT?	N/A	N/A	Flare Traversable RT?	N/A
N/A	Landing Length (in)	N/A	N/A	DWS Provided?	N/A
N/A	Landing Width (in)	N/A	N/A	DWS Contrast?	N/A
N/A	Landing Slope (%)	N/A	N/A	DWS Length (in)	N/A
N/A	Landing X Slope (%)	N/A	N/A	DWS Full Width?	N/A
N/A	Landing Curb? (Y/N)	N/A	N/A	DWS Offset (in)	N/A
N/A	Shared Landing?	N/A			
N/A	Gutter Ponding?	N/A	N/A	Gutter Slope (%)	N/A
N/A	Gutter Lip Ht (in)	N/A	N/A	Gutter X Slope (%)	N/A
N/A	Painted X Walk1?	Yes	N/A	Painted X Walk2?	N/A
	X Walk 1 Direction	To E		X Walk 2 Direction	N/A
N/A	X Walk 1 Width (in)	72.0	N/A	X Walk 2 Width (in)	N/A
	X Walk 1 Slope (%)	2.6		X Walk 2 Slope (%)	N/A
	X Walk 1 X Slope (%)	2.0		X Walk 2 X Slope (%)	N/A

N/A	Ramp inside XWalk1?	Yes	N/A	Ramp inside XWalk2?	N/A
	Road Slope (%)	N/A	N/A	Clear Space?	N/A
	Road X Slope (%)	N/A	N/A	Clear Space to XWalk (in)	N/A
N/A	Any Obstructions?	N/A	N/A	Storm Grate/Utility Hazard?	N/A
	Obstruction Type			Storm Grate/Utility Type	
		N/A			N/A
			Yes	Surface Condition? (G/P)	Good

Possible Solutions:

Remove & Replace Entire Ramp.
