# Access Compliance Report

## Public Rights-of-Way

| Intersection ID: 28425 | Main Street: CHASTAIN_PARC_DR | Cross Street: HOSTE_WAY_LN | Location: | N |
| ADA ID: 02FDC8DAD411 | Ramp Type: BlendTrans1 | Initial Pass/Fail: Fail | Overall Compliance: No | Severity Score: 10 |

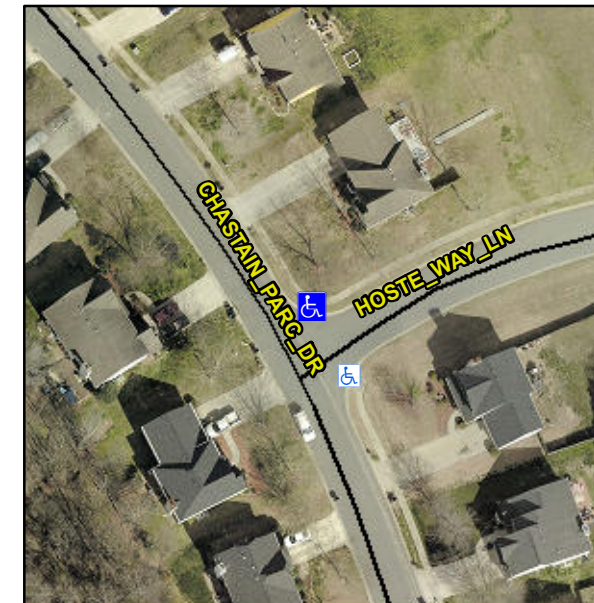
| Compliance | Description | Data | Compliance | Description | Data |
|---|---|---|---|---|---|
| N/A | Ramp Length (in) | 46.5 | Yes | BlendTrans Slope (%) | 3.2 |
| No | Ramp Width (in) | 41.5 | No | BlendTrans XSlope (%) | 4.1 |

**Remove & Replace Curb Ramp With Two New Directional Ramps or Equivalent.**
