## Access Compliance Report Public Rights-of-Way (Curb Ramps)

Intersection ID: 24904 Main Street: PROVIDENCE\_RD Cross Street: PINEVILLE-MATTHEWS\_RD Location: SE

ADA ID: 0301C3943D0A Ramp Type: IslandPerp Initial Pass/Fail: Fail Overall Compliance: No Severity Score: 21.25

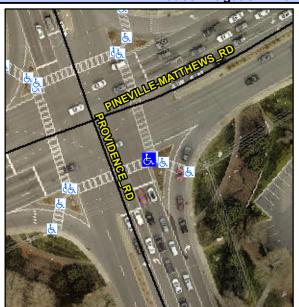
| Possible Solutions: | 9 |
|---|---|
| Not Found, R304.5.1, R304.2.2 | |

| Field Measurements/Component Compliance | | | | | | | |
|---|---|---|---|---|---|--|--|
| N/A | Ramp Length (in) | 34.0 | No | Ramp Slope (%) | 9.0 | | |
| No | Ramp Width (in) | 45.0 | Yes | Ramp XSlope (%) | 1.6 | | |

| Possible Solutions: | 9 |
|---|---|
| Remove & Replace Entire Ramp. | ı |

| Total Cost: | \$<br>3400.00 |
