Access Compliance Report

Public Rights-of-Way

(Curb Ramps)

Intersection ID: 15624	Main Street: ORDERMORE_AV	Cross Street: SCOTT_AV	Location: NE
ADA ID: 03099D642087	Ramp Type: Directional1	Initial Pass/Fail: Fail	Overall Compliance: No
Codes/Mitigation Info/Possible Solution		Field Measurements/Component Compliance	
Severity Score: 26.25

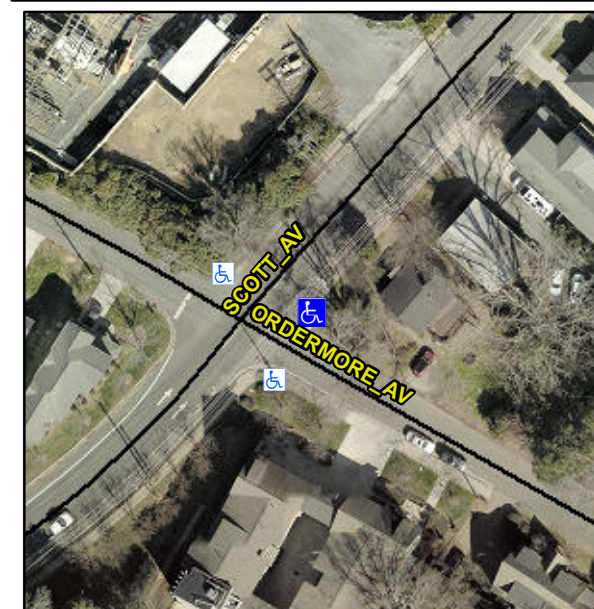
R304.2.2, R304.5.3

Compliance	Description	Data	Compliance	Description	Data
N/A	Ramp Length (in)	63.0	N/A	Grade Break?	N/A
Yes	Ramp Width (in)	52.0	N/A	Grade Break Slope (%)	0.0
No	Ramp Slope (%)	15.1	N/A	Grade Break XSlope (%)	0.0
No	Ramp XSlope (%)	4.6			
N/A	Flare Type LT	N/A	N/A	Flare Type RT	N/A
N/A	Flare Slope LT (%)	N/A	N/A	Flare Slope RT (%)	0.0
N/A	Flare Traversable LT?	N/A	N/A	Flare Traversable RT?	N/A
N/A	Landing Length (in)	0.0	N/A	DWS Provided?	N/A
N/A	Landing Width (in)	0.0	N/A	DWS Contrast?	N/A
N/A	Landing Slope (%)	0.0	N/A	DWS Length (in)	N/A
N/A	Landing X Slope (%)	0.0	N/A	DWS Full Width?	N/A
N/A	Landing Curb? (Y/N)	N/A	N/A	DWS Offset LT (in)	N/A
N/A	Shared Landing?	N/A	N/A	DWS Offset RT (in)	N/A
N/A	Gutter Ponding?	0.0	N/A	Gutter Slope (%)	N/A
N/A	Gutter Lip Ht (in)	0.0	N/A	Gutter X Slope (%)	N/A
N/A	Painted X Walk1?	No		Road Slope (%)	2.0
	X Walk 1 Direction	To SW		Road X Slope (%)	7.7
	X Walk 1 Width (in)	N/A		Clear Space?	N/A

X Walk 1 Slope (%)	2.0	N/A	Clear Space to XWalk (in)	N/A
	X Walk 1 X Slope (%)	7.7	N/A	Storm Grate/Utility Hazard?	N/A
N/A	Ramp inside XWalk1?	N/A		Storm Grate/Utility Type	
N/A	Any Obstructions?	N/A			N/A
	Obstruction Type		Yes	Surface Condition? (G/P)	Good
			N/A	Curb Slope (%)	10.1

Possible Solutions:

Remove & Replace Entire Ramp.

Total Cost: \$ 1600.00
