Access Compliance Report

Public Rights-of-Way

(Curb Ramps)

Intersection ID: 48984	Main Street: ASHTON_GATE_DR	Cross Street: KINGSDOWN_AV	Location: SW
ADA ID: 030A182C95E5	Ramp Type: PerpDiag	Initial Pass/Fail: Fail	Overall Compliance: No
		Severity Score: 10

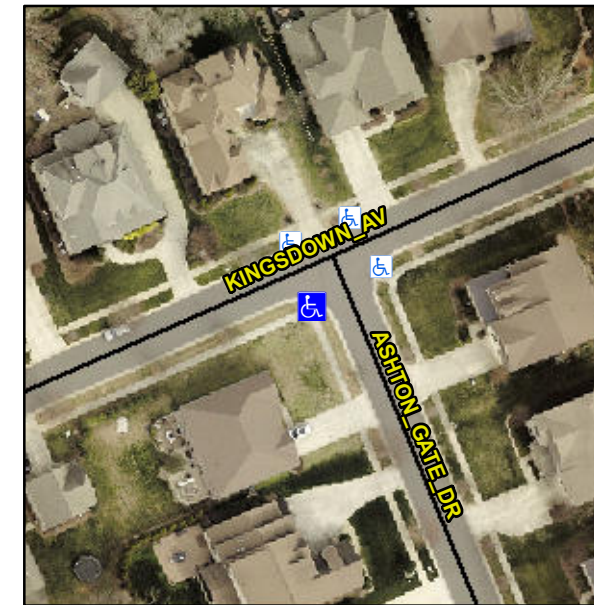
Compliance	Description	Data	Compliance	Description	Data
N/A	Ramp Length (in)	70.0	Yes	Ramp Slope (%)	5.2
No	Ramp Width (in)	46.0	No	Ramp XSlope (%)	3.9
N/A	Flare Type LT	N/A	N/A	Flare Type RT	N/A
N/A	Flare Slope LT (%)	N/A	N/A	Flare Slope RT (%)	N/A
N/A	Flare Traversable LT?	N/A	N/A	Flare Traversable RT?	N/A
N/A	Landing Length (in)	N/A	N/A	DWS Provided?	N/A
N/A	Landing Width (in)	N/A	N/A	DWS Contrast?	N/A
N/A	Landing Slope (%)	N/A	N/A	DWS Length (in)	N/A
N/A	Landing X Slope (%)	N/A	N/A	DWS Full Width?	N/A
N/A	Landing Curb? (Y/N)	N/A	N/A	DWS Offset (in)	N/A
N/A	Shared Landing?	N/A			
N/A	Gutter Ponding?	N/A	N/A	Gutter Slope (%)	N/A
N/A	Gutter Lip Ht (in)	N/A	N/A	Gutter X Slope (%)	N/A
N/A	Painted X Walk1?	No	N/A	Painted X Walk2?	No
	X Walk 1 Direction	To E		X Walk 2 Direction	To N
N/A	X Walk 1 Width (in)	N/A	N/A	X Walk 2 Width (in)	N/A
	X Walk 1 Slope (%)	0.9		X Walk 2 Slope (%)	5.4
	X Walk 1 X Slope (%)	3.7		X Walk 2 X Slope (%)	1.8

Remove & Replace Curb Ramp With Two New Directional Ramps or Equivalent.

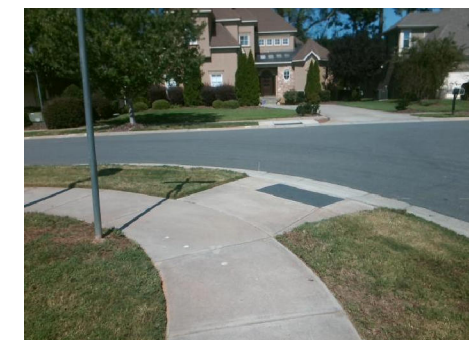
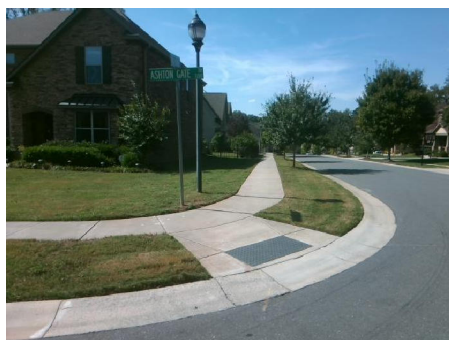
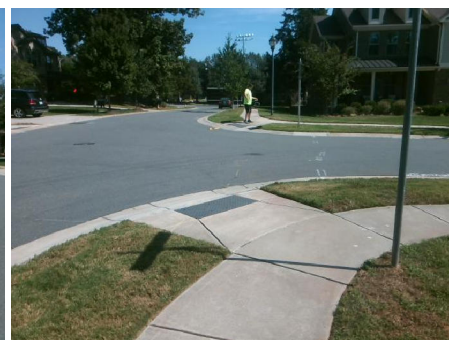
Not Found, R304.5.1, R304.5.3

N/A	Ramp inside XWalk1?	N/A	N/A	Ramp inside XWalk2?	N/A
	Road Slope (%)	3.4	N/A	Clear Space?	N/A
	Road X Slope (%)	3.6	N/A	Clear Space to XWalk (in)	N/A
N/A	Any Obstructions?	N/A	N/A	Storm Grate/Utility Hazard?	N/A
	Obstruction Type			Storm Grate/Utility Type	
		N/A			N/A
			Yes	Surface Condition? (G/P)	Good
