Access Compliance Report

Public Rights-of-Way

(Curb Ramps)

Intersection ID: 8684	Main Street: CENTRE_ST	Cross Street: DARBY_AV	Location:	N
ADA ID: 03147EC3ACE5	Ramp Type: BlendTrans2	Initial Pass/Fail: Fail	Overall Compliance: No	Severity Score: 10

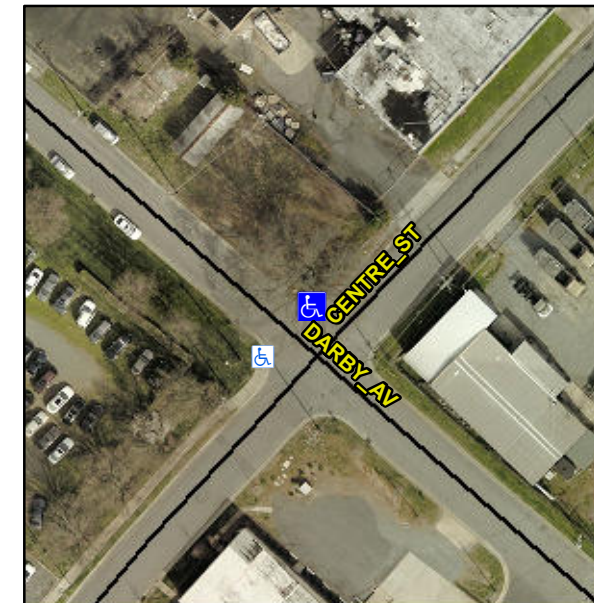
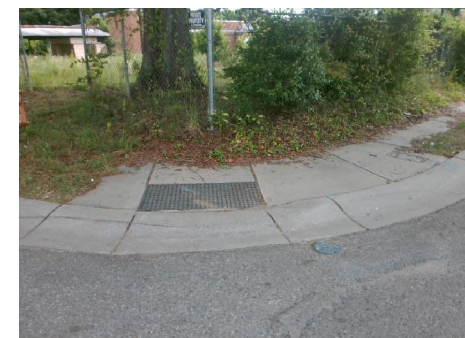
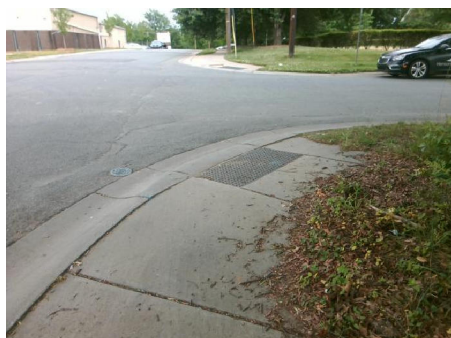
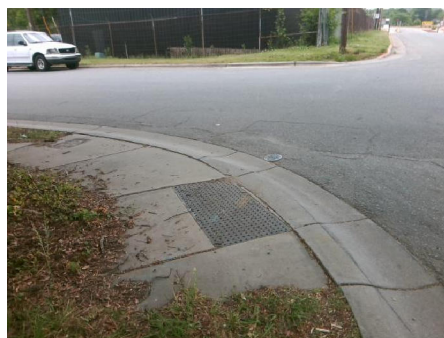
NO LT SW

Compliance	Description	Data	Compliance	Description	Data
N/A	Ramp Length (in)	59.0	Yes	BlendTrans Slope (%)	4.5
No	Ramp Width (in)	47.0	No	BlendTrans XSlope (%)	4.1
N/A	Flare Type LT	N/A	N/A	Flare Type RT	N/A
N/A	Flare Slope LT (%)	N/A	N/A	Flare Slope RT (%)	N/A
N/A	Flare Traversable LT?	N/A	N/A	Flare Traversable RT?	N/A
N/A	Landing Length (in)	N/A	N/A	DWS Provided?	N/A
N/A	Landing Width (in)	N/A	N/A	DWS Contrast?	N/A
N/A	Landing Slope (%)	N/A	N/A	DWS Length (in)	N/A
N/A	Landing X Slope (%)	N/A	N/A	DWS Full Width?	N/A
N/A	Landing Curb? (Y/N)	N/A	N/A	DWS Offset (in)	N/A
N/A	Shared Landing?	N/A			
N/A	Gutter Ponding?	N/A	N/A	Gutter Slope (%)	N/A
N/A	Gutter Lip Ht (in)	N/A	N/A	Gutter X Slope (%)	N/A
N/A	Painted X Walk1?	No	N/A	Painted X Walk2?	N/A
	X Walk 1 Direction	To SW		X Walk 2 Direction	N/A
	X Walk 1 Width (in)	N/A		X Walk 2 Width (in)	N/A
	X Walk 1 Slope (%)	2.7		X Walk 2 Slope (%)	N/A
	X Walk 1 X Slope (%)	2.0		X Walk 2 X Slope (%)	N/A

N/A	Ramp inside XWalk1?	N/A	N/A	Ramp inside XWalk2?	N/A
	Road Slope (%)	2.0		Clear Space?	N/A
	Road X Slope (%)	2.7	N/A	Clear Space to XWalk (in)	N/A
N/A	Any Obstructions?	N/A	N/A	Storm Grate/Utility Hazard?	N/A
	Obstruction Type			Storm Grate/Utility Type	
		N/A			N/A
			Yes	Surface Condition? (G/P)	Good
			N/A	Curb Slope (%)	N/A

Possible Solutions:

Remove & Replace Curb Ramp With Two New Directional Ramps or Equivalent.
