# Access Compliance Report

## Public Rights-of-Way

### (Curb Ramps)

| Intersection ID: 10024220 | Main Street: COVENTRY COURT LN | Cross Street: N/A | Location: NW |

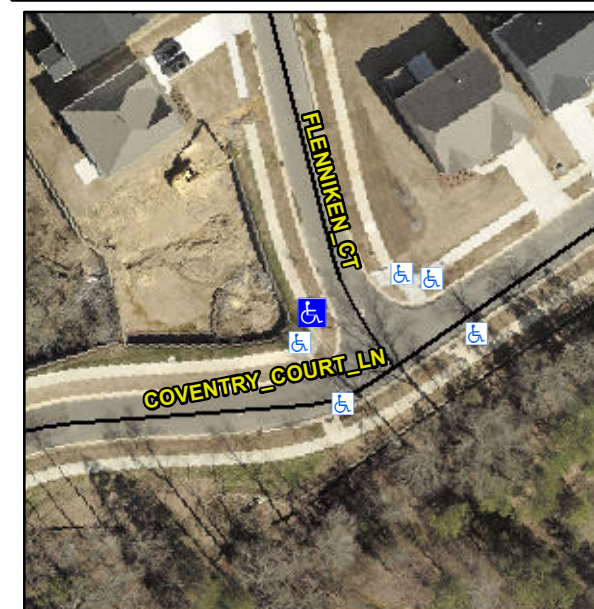
**Not Found, R304.5.4**

| Compliance | Description | Data | Compliance | Description | Data |
|---|---|---|---|---|---|
| Yes | Gutter Ponding? | No | No | Gutter Slope (%) | 5.4 |

**Remove & Replace Entire Ramp.  
Remove & Replace Gutter.**
