# Access Compliance Report

## Public Rights-of-Way

### (Curb Ramps)

Intersection ID: 7613	Main Street: N_TRYON_ST	Cross Street: HEATHWAY_DR	Location: NE
ADA ID: 0319D89911E7	Ramp Type: Combination2	Initial Pass/Fail: Fail	Overall Compliance: No
		Severity Score: 1.25

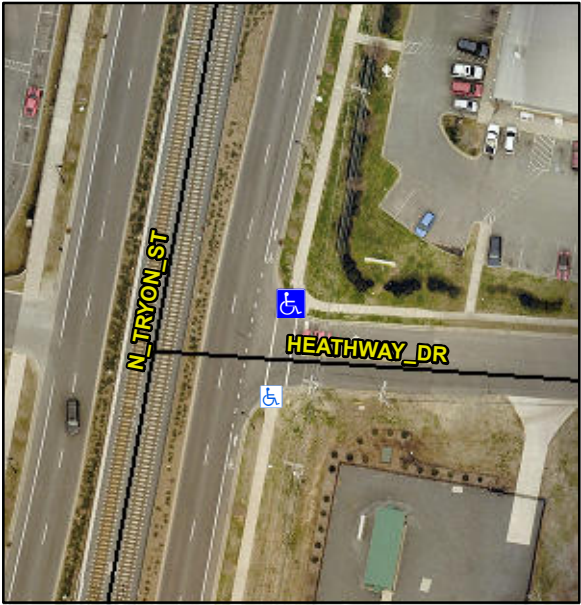
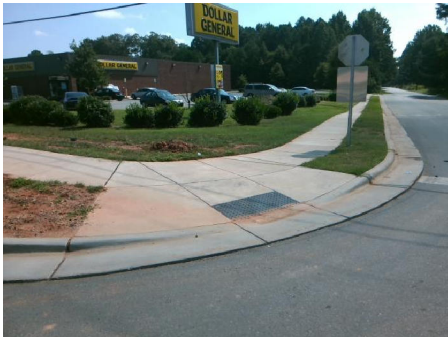
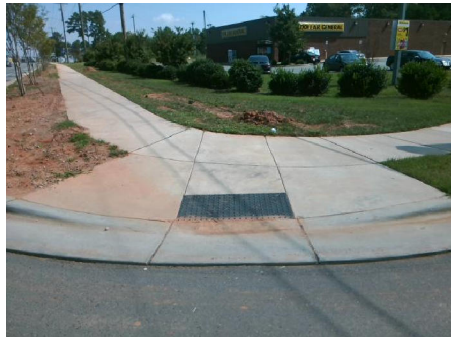
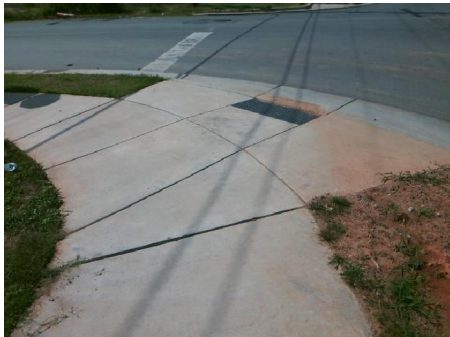
Possible Solutions:		<b>Compliance</b>	<b>Description</b>	<b>Data</b>
	<b>Remove &amp; Replace Entire Ramp.</b>		N/A	Ramp Length LT (in)	13.0
			Yes	Ramp Width LT (in)	74.0
			Yes	Ramp Slope LT (%)	5.6
			No	Ramp XSlope LT (%)	2.6
			N/A	Ramp Length (in)	58.0
			Yes	Ramp Width (in)	48.0
			N/A	Flare Type LT	N/A
			N/A	Flare Slope LT (%)	N/A
			N/A	Flare Traversable LT?	N/A
<p>Surveyor Notes:</p> <p><b>RT RP &lt; 5%</b></p> <p>PROW/ADA:</p> <p><b>R304.5.3</b></p>			N/A	Ramp Length RT (in)	39.5
			N/A	Ramp Width RT (in)	70.0
			N/A	Ramp Slope RT (%)	1.8
			N/A	Ramp XSlope RT (%)	1.7
			Yes	Ramp Slope (%)	6.4
			Yes	Ramp XSlope (%)	0.2
			N/A	Flare Type RT	N/A
			N/A	Flare Slope RT (%)	N/A
			N/A	Flare Traversable RT?	N/A
			N/A	DWS Provided?	N/A
<p>Street 1 Name</p> <p>Stop Condition-Street 1</p> <p>Street 2 Name</p> <p>Stop Condition-Street 2</p>			N/A	DWS Contrast?	N/A
