# Access Compliance Report

## Public Rights-of-Way

### (Curb Ramps)

Intersection ID: 12428	Main Street: E_7TH_ST	Cross Street: N_CALDWELL_ST	Location: E
ADA ID: 031A28CDA333	Ramp Type: PerpDiag	Initial Pass/Fail: Fail	Overall Compliance: No
		Severity Score: 10

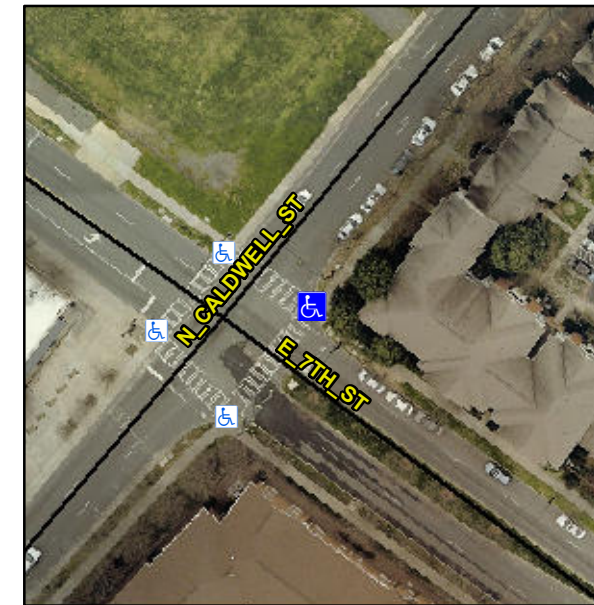
Compliance	Description	Data	Compliance	Description	Data
N/A	Ramp Length (in)	84.0	Yes	Ramp Slope (%)	6.8
No	Ramp Width (in)	41.0	No	Ramp XSlope (%)	2.2
N/A	Flare Type LT	N/A	N/A	Flare Type RT	N/A
N/A	Flare Slope LT (%)	N/A	N/A	Flare Slope RT (%)	N/A
N/A	Flare Traversable LT?	N/A	N/A	Flare Traversable RT?	N/A
N/A	Landing Length (in)	N/A	N/A	DWS Provided?	N/A
N/A	Landing Width (in)	N/A	N/A	DWS Contrast?	N/A
N/A	Landing Slope (%)	N/A	N/A	DWS Length (in)	N/A
N/A	Landing X Slope (%)	N/A	N/A	DWS Full Width?	N/A
N/A	Landing Curb? (Y/N)	N/A	N/A	DWS Offset (in)	N/A
N/A	Shared Landing?	N/A			
N/A	Gutter Ponding?	Yes	N/A	Gutter Slope (%)	N/A
N/A	Gutter Lip Ht (in)	1.0	N/A	Gutter X Slope (%)	N/A
N/A	Painted X Walk1?	Yes	N/A	Painted X Walk2?	Yes
	X Walk 1 Direction	To NW		X Walk 2 Direction	To SW
N/A	X Walk 1 Width (in)	130.0	N/A	X Walk 2 Width (in)	85.0
	X Walk 1 Slope (%)	3.5		X Walk 2 Slope (%)	0.0
	X Walk 1 X Slope (%)	2.3		X Walk 2 X Slope (%)	3.0

N/A	Ramp inside XWalk1?	Yes	N/A	Ramp inside XWalk2?	Yes
	Road Slope (%)	1.3	N/A	Clear Space?	N/A
	Road X Slope (%)	2.9	N/A	Clear Space to XWalk (in)	N/A
N/A	Any Obstructions?	N/A	N/A	Storm Grate/Utility Hazard?	N/A
	Obstruction Type			Storm Grate/Utility Type	
		N/A			N/A
		Yes		Surface Condition? (G/P)	Good

**Remove & Replace Curb Ramp With Two New Directional Ramps or Equivalent.**

**R304.5.1, R304.5.3**

Total Cost: \$ 3200.00
