# Access Compliance Report

## Public Rights-of-Way

### (Curb Ramps)

Intersection ID: 49130	Main Street: AUBURN_HILL_LN	Cross Street: WILTSHIRE_RIDGE_RD	Location: SE
ADA ID: 031A47F17D21	Ramp Type: Perp	Initial Pass/Fail: Fail	Overall Compliance: No
Severity Score: 1.25			
Codes/Mitigation Info/Possible Solution		Field Measurements/Component Compliance

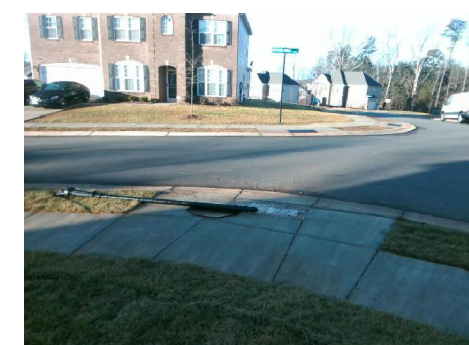
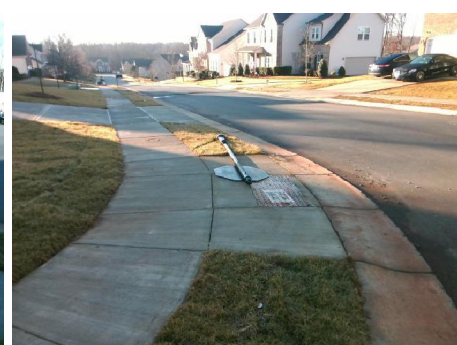
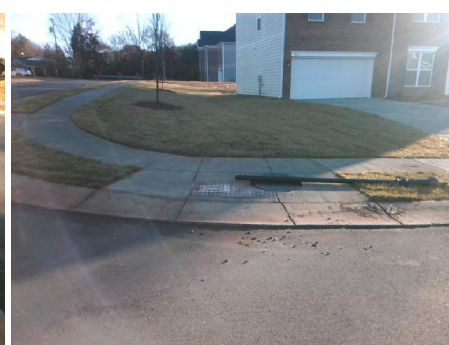
Compliance	Description	Data	Compliance	Description	Data
N/A	Ramp Length (in)	48.5	Yes	Ramp Slope (%)	7.1
Yes	Ramp Width (in)	48.0	No	Ramp XSlope (%)	3.3
N/A	Flare Type LT	N/A	N/A	Flare Type RT	N/A
N/A	Flare Slope LT (%)	N/A	N/A	Flare Slope RT (%)	N/A
N/A	Flare Traversable LT?	N/A	N/A	Flare Traversable RT?	N/A
N/A	Landing Length (in)	N/A	N/A	DWS Provided?	N/A
N/A	Landing Width (in)	N/A	N/A	DWS Contrast?	N/A
N/A	Landing Slope (%)	N/A	N/A	DWS Length (in)	N/A
N/A	Landing X Slope (%)	N/A	N/A	DWS Full Width?	N/A
N/A	Landing Curb? (Y/N)	N/A	N/A	DWS Offset (in)	N/A
N/A	Shared Landing?	N/A			
N/A	Gutter Ponding?	N/A	N/A	Gutter Slope (%)	N/A
N/A	Gutter Lip Ht (in)	N/A	N/A	Gutter X Slope (%)	N/A
N/A	Painted X Walk1?	No	N/A	Painted X Walk2?	N/A
	X Walk 1 Direction	To W		X Walk 2 Direction	N/A
N/A	X Walk 1 Width (in)	N/A	N/A	X Walk 2 Width (in)	N/A
	X Walk 1 Slope (%)	3.0		X Walk 2 Slope (%)	N/A
	X Walk 1 X Slope (%)	5.6		X Walk 2 X Slope (%)	N/A

N/A	Ramp inside XWalk1?	N/A	N/A	Ramp inside XWalk2?	N/A
	Road Slope (%)	N/A	N/A	Clear Space?	N/A
	Road X Slope (%)	N/A	N/A	Clear Space to XWalk (in)	N/A
N/A	Any Obstructions?	N/A	N/A	Storm Grate/Utility Hazard?	N/A
	Obstruction Type			Storm Grate/Utility Type	
		N/A			N/A
		Yes		Surface Condition? (G/P)	Good

Possible Solutions:

**Remove & Replace Entire Ramp.**

**Not Found, R304.5.3**
