Access Compliance Report

Public Rights-of-Way

(Curb Ramps)

Intersection ID: 14082	Main Street: OLD_STEELE_CREEK_RD	Cross Street: MARKLAND_DR	Location: SW
ADA ID: 0326F236BCC1	Ramp Type: PerpDiag	Initial Pass/Fail: Fail	Overall Compliance: No
		Severity Score: 8.75

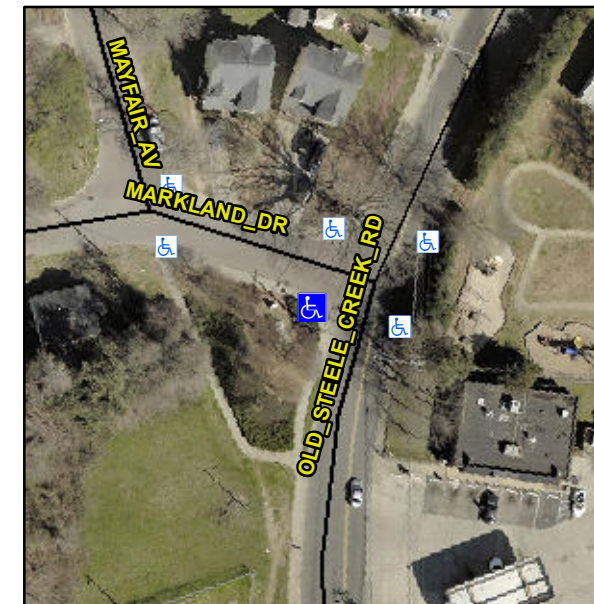
Not Found, R304.5.1

Compliance	Description	Data	Compliance	Description	Data
N/A	Ramp Length (in)	60.0	Yes	Ramp Slope (%)	5.4
No	Ramp Width (in)	45.0	Yes	Ramp XSlope (%)	1.6
N/A	Flare Type LT	N/A	N/A	Flare Type RT	N/A
N/A	Flare Slope LT (%)	N/A	N/A	Flare Slope RT (%)	N/A
N/A	Flare Traversable LT?	N/A	N/A	Flare Traversable RT?	N/A
N/A	Landing Length (in)	N/A	N/A	DWS Provided?	N/A
N/A	Landing Width (in)	N/A	N/A	DWS Contrast?	N/A
N/A	Landing Slope (%)	N/A	N/A	DWS Length (in)	N/A
N/A	Landing X Slope (%)	N/A	N/A	DWS Full Width?	N/A
N/A	Landing Curb? (Y/N)	N/A	N/A	DWS Offset (in)	N/A
N/A	Shared Landing?	N/A			
N/A	Gutter Ponding?	N/A	N/A	Gutter Slope (%)	N/A
N/A	Gutter Lip Ht (in)	N/A	N/A	Gutter X Slope (%)	N/A
N/A	Painted X Walk1?	No	N/A	Painted X Walk2?	No
	X Walk 1 Direction	To E		X Walk 2 Direction	To N
N/A	X Walk 1 Width (in)	N/A	N/A	X Walk 2 Width (in)	N/A
	X Walk 1 Slope (%)	1.6		X Walk 2 Slope (%)	0.4
	X Walk 1 X Slope (%)	1.5		X Walk 2 X Slope (%)	0.7

N/A	Ramp inside XWalk1?	N/A	N/A	Ramp inside XWalk2?	N/A
	Road Slope (%)	3.1	N/A	Clear Space?	N/A
	Road X Slope (%)	3.5	N/A	Clear Space to XWalk (in)	N/A
N/A	Any Obstructions?	N/A	N/A	Storm Grate/Utility Hazard?	N/A
	Obstruction Type			Storm Grate/Utility Type	
		N/A			N/A
		Yes		Surface Condition? (G/P)	Good

Remove & Replace Curb Ramp With Two New Directional Ramps or Equivalent.
