Access Compliance Report

Public Rights-of-Way

(Curb Ramps)

Intersection ID: 12285	Main Street: E_TRADE_ST	Cross Street: N_TRYON_ST	Location: N
ADA ID: 032A2275471E	Ramp Type: Perp	Initial Pass/Fail: Pass	Overall Compliance: No
Severity Score: 2.75			
Codes/Mitigation Info/Possible Solution		Field Measurements/Component Compliance

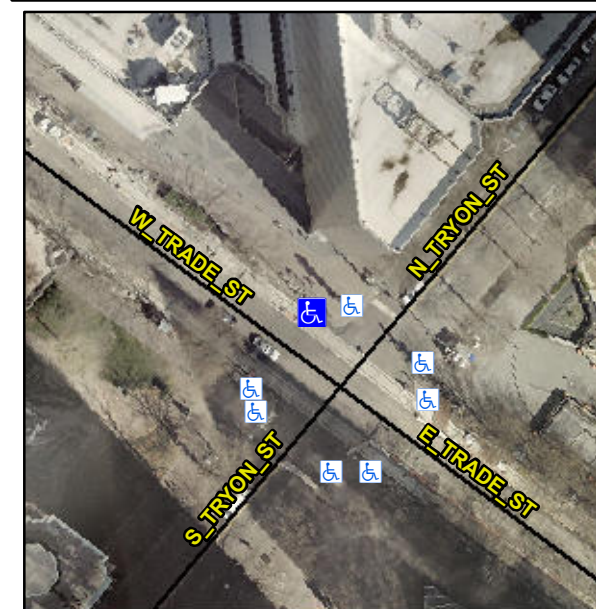
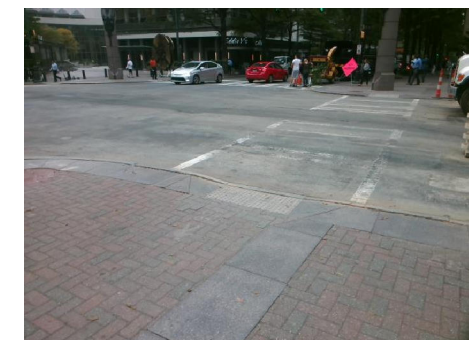
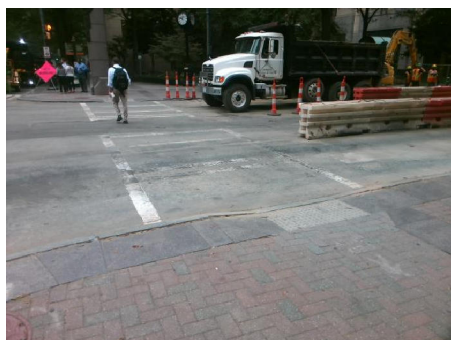
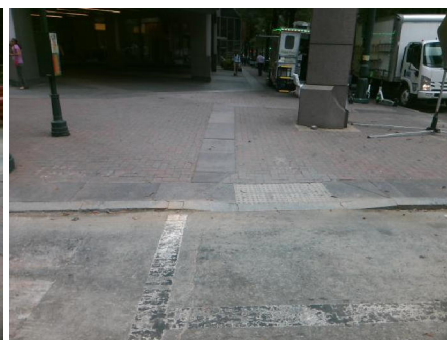
Not Found, R304.5.3, R304.2.3

Compliance	Description	Data	Compliance	Description	Data
N/A	Ramp Length (in)	24.0	Yes	Ramp Slope (%)	7.2
Yes	Ramp Width (in)	48.0	No	Ramp XSlope (%)	3.2
N/A	Flare Type LT	Sloped	N/A	Flare Type RT	N/A
N/A	Flare Slope LT (%)	5.5	No	Flare Slope RT (%)	11.2
N/A	Flare Traversable LT?	Yes	N/A	Flare Traversable RT?	Yes
Yes	Landing Length (in)	60.0	Yes	DWS Provided?	Yes
Yes	Landing Width (in)	60.0	Yes	DWS Contrast?	Yes
Yes	Landing Slope (%)	1.6	Yes	DWS Length (in)	24.0
Yes	Landing X Slope (%)	0.5	Yes	DWS Full Width?	Yes
N/A	Landing Curb? (Y/N)	No	Yes	DWS Offset (in)	0.0
N/A	Shared Landing?	No			
Yes	Gutter Ponding?	No	Yes	Gutter Slope (%)	0.4
Yes	Gutter Lip Ht (in)	0.0	Yes	Gutter X Slope (%)	0.9
N/A	Painted X Walk1?	Yes	N/A	Painted X Walk2?	N/A
	X Walk 1 Direction	To SW		X Walk 2 Direction	N/A
N/A	X Walk 1 Width (in)	114.0	N/A	X Walk 2 Width (in)	N/A
	X Walk 1 Slope (%)	0.4		X Walk 2 Slope (%)	N/A
	X Walk 1 X Slope (%)	0.9		X Walk 2 X Slope (%)	N/A

Yes	Ramp inside XWalk1?	Yes	N/A	Ramp inside XWalk2?	N/A
	Road Slope (%)	N/A	N/A	Clear Space?	Yes
	Road X Slope (%)	N/A	N/A	Clear Space to XWalk (in)	N/A
Yes	Any Obstructions?	No	Yes	Storm Grate/Utility Hazard?	No
	Obstruction Type			Storm Grate/Utility Type	
		N/A			N/A
			Yes	Surface Condition? (G/P)	Good

Remove & Replace Entire Ramp.
