# Access Compliance Report

## Public Rights-of-Way

### (Curb Ramps)

| Intersection ID: 18365 | Main Street: TRYON_ST | Cross Street: TYVOLA_RD | Location: SW |

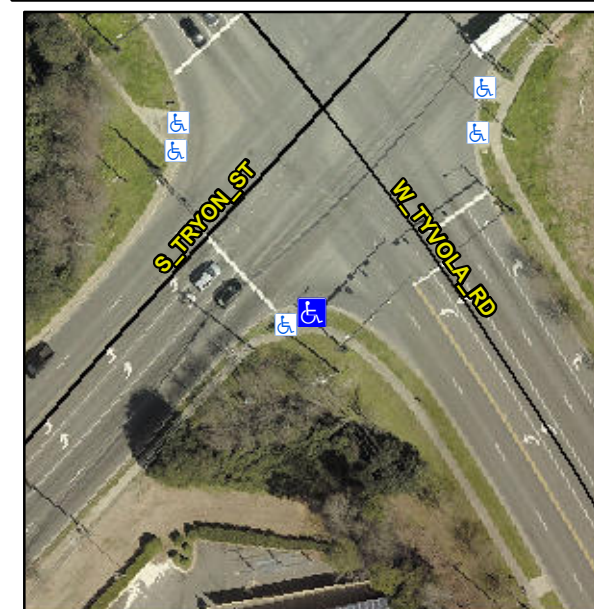
| Codes/Mitigation Info/Possible Solution | | | Severity Score: 5 |

PROW/ADA:

**R305.2, R304.5.4, R304.5.3**

| Compliance | Description | Data | Compliance | Description | Data |
|---|---|---|---|---|---|
| N/A | Landing Curb? (Y/N) | No | No | DWS Offset (in) | 4.0 |
| Yes | Gutter Ponding? | No | No | Gutter Slope (%) | 6.0 |
| Yes | Gutter Lip Ht (in) | 0.0 | No | Gutter X Slope (%) | 2.2 |

Possible Solutions:

**Remove & Replace Detectable Warning System. Remove & Replace Gutter.**

Total Cost: \$ 1550.00
