Access Compliance Report

Public Rights-of-Way

(Curb Ramps)

Intersection ID: 13488	Main Street: E_BLAND_ST	Cross Street: S_COLLEGE_ST	Location: E
ADA ID: 033E475A9AE5	Ramp Type: Perp	Initial Pass/Fail: Fail	Overall Compliance: No
Severity Score: 33.75			
Codes/Mitigation Info/Possible Solution		Field Measurements/Component Compliance

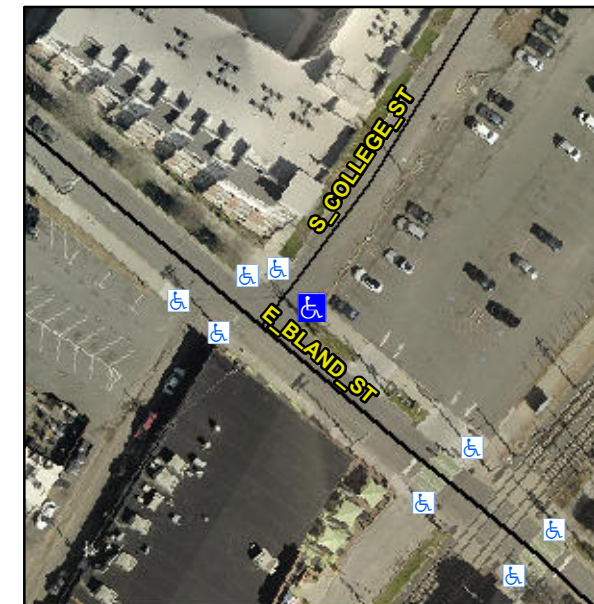
Compliance	Description	Data	Compliance	Description	Data
N/A	Ramp Length (in)	56.0	Yes	Ramp Slope (%)	6.9
No	Ramp Width (in)	47.0	No	Ramp XSlope (%)	8.2
N/A	Flare Type LT	N/A	N/A	Flare Type RT	N/A
N/A	Flare Slope LT (%)	N/A	N/A	Flare Slope RT (%)	N/A
N/A	Flare Traversable LT?	N/A	N/A	Flare Traversable RT?	N/A
N/A	Landing Length (in)	N/A	N/A	DWS Provided?	N/A
N/A	Landing Width (in)	N/A	N/A	DWS Contrast?	N/A
N/A	Landing Slope (%)	N/A	N/A	DWS Length (in)	N/A
N/A	Landing X Slope (%)	N/A	N/A	DWS Full Width?	N/A
N/A	Landing Curb? (Y/N)	N/A	N/A	DWS Offset (in)	N/A
N/A	Shared Landing?	N/A			
N/A	Gutter Ponding?	N/A	N/A	Gutter Slope (%)	N/A
N/A	Gutter Lip Ht (in)	N/A	N/A	Gutter X Slope (%)	N/A
N/A	Painted X Walk1?	No	N/A	Painted X Walk2?	N/A
	X Walk 1 Direction	To NW		X Walk 2 Direction	N/A
N/A	X Walk 1 Width (in)	N/A	N/A	X Walk 2 Width (in)	N/A
	X Walk 1 Slope (%)	4.0		X Walk 2 Slope (%)	N/A
	X Walk 1 X Slope (%)	9.6		X Walk 2 X Slope (%)	N/A

N/A	Ramp inside XWalk1?	N/A	N/A	Ramp inside XWalk2?	N/A
	Road Slope (%)	N/A	N/A	Clear Space?	N/A
	Road X Slope (%)	N/A	N/A	Clear Space to XWalk (in)	N/A
N/A	Any Obstructions?	N/A	N/A	Storm Grate/Utility Hazard?	N/A
	Obstruction Type			Storm Grate/Utility Type	
		N/A			N/A
			Yes	Surface Condition? (G/P)	Good

Possible Solutions:

Remove & Replace Entire Ramp.
