# Access Compliance Report

## Public Rights-of-Way

### (Curb Ramps)

Intersection ID: 12285	Main Street: E_TRADE_ST	Cross Street: N_TRYON_ST	Location: S
ADA ID: 0349B768C324	Ramp Type: Perp	Initial Pass/Fail: Fail	Overall Compliance: No
Severity Score: 13.75			
Codes/Mitigation Info/Possible Solution		Field Measurements/Component Compliance

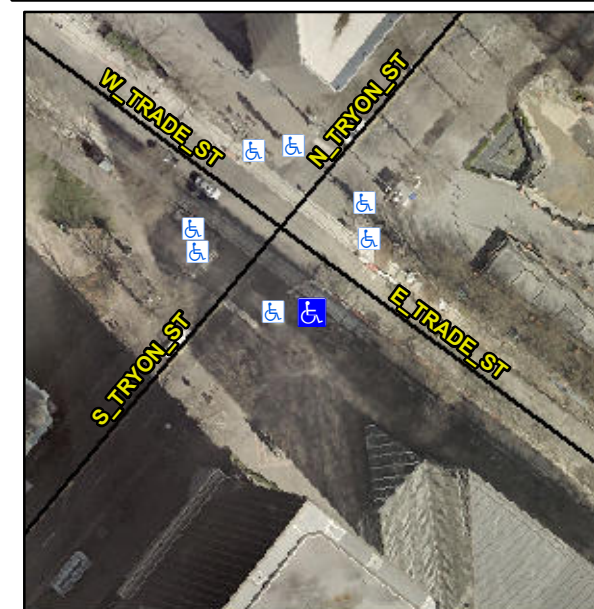
Compliance	Description	Data	Compliance	Description	Data
N/A	Ramp Length (in)	23.5	No	Ramp Slope (%)	9.2
Yes	Ramp Width (in)	48.0	Yes	Ramp XSlope (%)	3.4
N/A	Flare Type LT	N/A	N/A	Flare Type RT	N/A
N/A	Flare Slope LT (%)	N/A	N/A	Flare Slope RT (%)	N/A
N/A	Flare Traversable LT?	N/A	N/A	Flare Traversable RT?	N/A
N/A	Landing Length (in)	N/A	N/A	DWS Provided?	N/A
N/A	Landing Width (in)	N/A	N/A	DWS Contrast?	N/A
N/A	Landing Slope (%)	N/A	N/A	DWS Length (in)	N/A
N/A	Landing X Slope (%)	N/A	N/A	DWS Full Width?	N/A
N/A	Landing Curb? (Y/N)	N/A	N/A	DWS Offset (in)	N/A
N/A	Shared Landing?	N/A			
N/A	Gutter Ponding?	N/A	N/A	Gutter Slope (%)	N/A
N/A	Gutter Lip Ht (in)	N/A	N/A	Gutter X Slope (%)	N/A
N/A	Painted X Walk1?	Yes	N/A	Painted X Walk2?	N/A
	X Walk 1 Direction	To NE		X Walk 2 Direction	N/A
N/A	X Walk 1 Width (in)	160.0	N/A	X Walk 2 Width (in)	N/A
	X Walk 1 Slope (%)	0.7		X Walk 2 Slope (%)	N/A
	X Walk 1 X Slope (%)	6.2		X Walk 2 X Slope (%)	N/A

N/A	Ramp inside XWalk1?	Yes	N/A	Ramp inside XWalk2?	N/A
	Road Slope (%)	N/A	N/A	Clear Space?	N/A
	Road X Slope (%)	N/A	N/A	Clear Space to XWalk (in)	N/A
N/A	Any Obstructions?	N/A	N/A	Storm Grate/Utility Hazard?	N/A
	Obstruction Type			Storm Grate/Utility Type	
		N/A			N/A
		Yes		Surface Condition? (G/P)	Good

Possible Solutions:

**Remove & Replace Entire Ramp.**

**R304.2.2**

Total Cost: \$ 1850.00
