# Access Compliance Report

## Public Rights-of-Way

### (Curb Ramps)

| Intersection ID: 13247 | Main Street: MERRIMAN_AV | Cross Street: W_KINGSTON_AV | Location: SW |

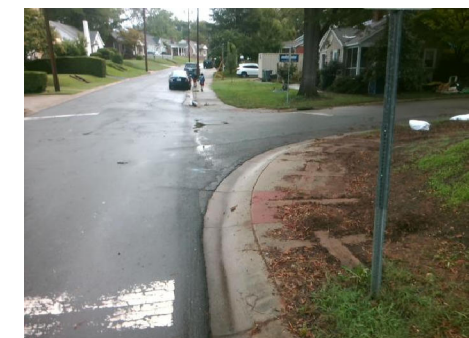
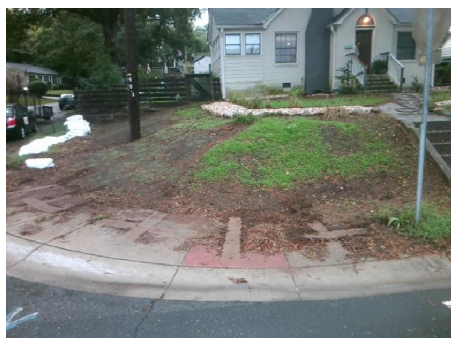
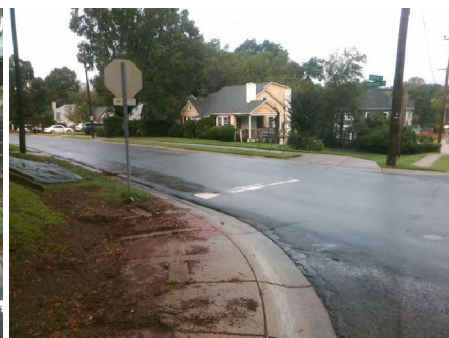
| ADA ID: 0371BA95333E | Ramp Type: Para | Initial Pass/Fail: Fail | Overall Compliance: No |
| Severity Score: 1.25 | | | |

| Compliance | Description | Data | Compliance | Description | Data |
|---|---|---|---|---|---|
| No | Ramp XSlope LT (%) | 3.2 | N/A | Ramp XSlope RT (%) | N/A |

**Remove & Replace Entire Ramp.**

**R304.5.3**
