# Access Compliance Report

## Public Rights-of-Way

### (Curb Ramps)

Intersection ID: 12783	Main Street: 5TH_ST	Cross Street: ALEXANDER_RD	Location: E
ADA ID: 037F4ECAB6EC	Ramp Type: Perp	Initial Pass/Fail: Fail	Overall Compliance: No
		Severity Score: 12.5

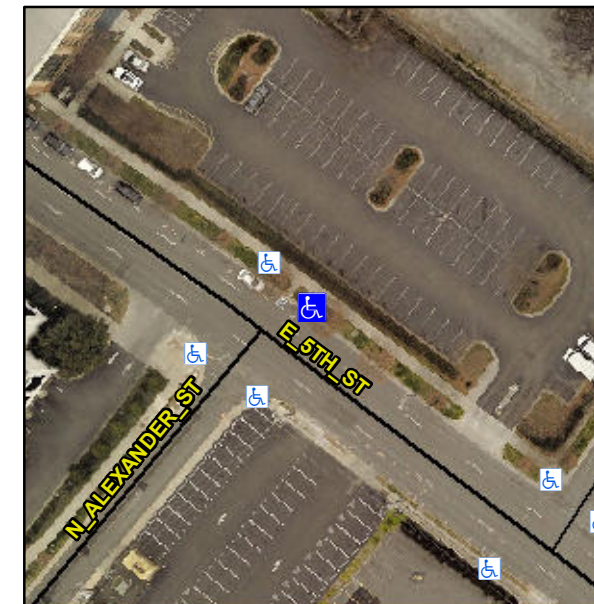
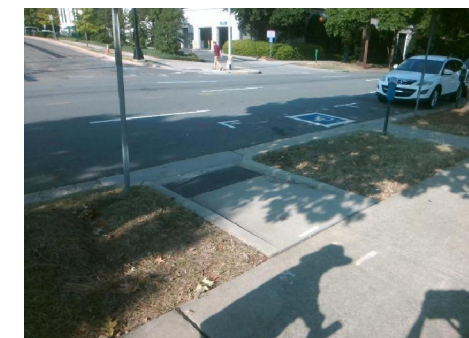
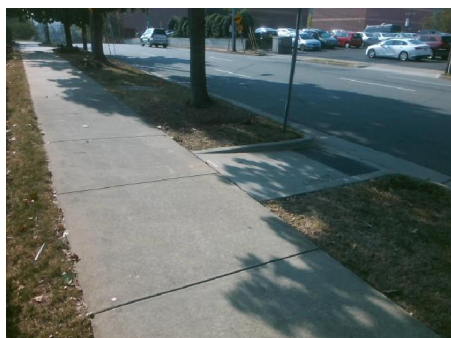
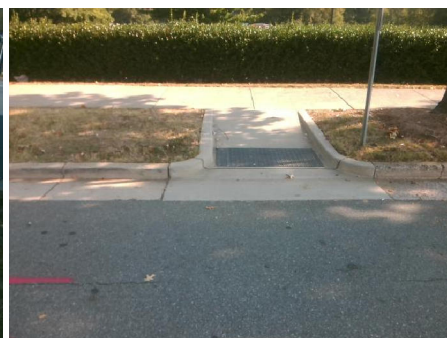
**Not Found, R304.2.2**

Compliance	Description	Data	Compliance	Description	Data
N/A	Ramp Length (in)	94.0	No	Ramp Slope (%)	9.8
Yes	Ramp Width (in)	59.0	Yes	Ramp XSlope (%)	0.6
N/A	Flare Type LT	N/A	N/A	Flare Type RT	N/A
N/A	Flare Slope LT (%)	N/A	N/A	Flare Slope RT (%)	N/A
N/A	Flare Traversable LT?	N/A	N/A	Flare Traversable RT?	N/A
N/A	Landing Length (in)	N/A	N/A	DWS Provided?	N/A
N/A	Landing Width (in)	N/A	N/A	DWS Contrast?	N/A
N/A	Landing Slope (%)	N/A	N/A	DWS Length (in)	N/A
N/A	Landing X Slope (%)	N/A	N/A	DWS Full Width?	N/A
N/A	Landing Curb? (Y/N)	N/A	N/A	DWS Offset (in)	N/A
N/A	Shared Landing?	N/A			
N/A	Gutter Ponding?	N/A	N/A	Gutter Slope (%)	N/A
N/A	Gutter Lip Ht (in)	N/A	N/A	Gutter X Slope (%)	N/A
N/A	Painted X Walk1?	No	N/A	Painted X Walk2?	N/A
	X Walk 1 Direction	To SW		X Walk 2 Direction	N/A
N/A	X Walk 1 Width (in)	N/A	N/A	X Walk 2 Width (in)	N/A
	X Walk 1 Slope (%)	3.9		X Walk 2 Slope (%)	N/A
	X Walk 1 X Slope (%)	2.1		X Walk 2 X Slope (%)	N/A

N/A	Ramp inside XWalk1?	N/A	N/A	Ramp inside XWalk2?	N/A
	Road Slope (%)	N/A	N/A	Clear Space?	N/A
	Road X Slope (%)	N/A	N/A	Clear Space to XWalk (in)	N/A
N/A	Any Obstructions?	N/A	N/A	Storm Grate/Utility Hazard?	N/A
	Obstruction Type			Storm Grate/Utility Type	
		N/A			N/A
			Yes	Surface Condition? (G/P)	Good

**Remove & Replace Entire Ramp.**
