Access Compliance Report

Public Rights-of-Way

(Curb Ramps)

Intersection ID: 27432	Main Street: BALLANTYNE_COMMONS_PY	Cross Street: DURANT_BV	Location: NE
ADA ID: 039676BB9B31	Ramp Type: Perp	Initial Pass/Fail: Fail	Overall Compliance: No
Severity Score: 37.5			
Codes/Mitigation Info/Possible Solution		Field Measurements/Component Compliance

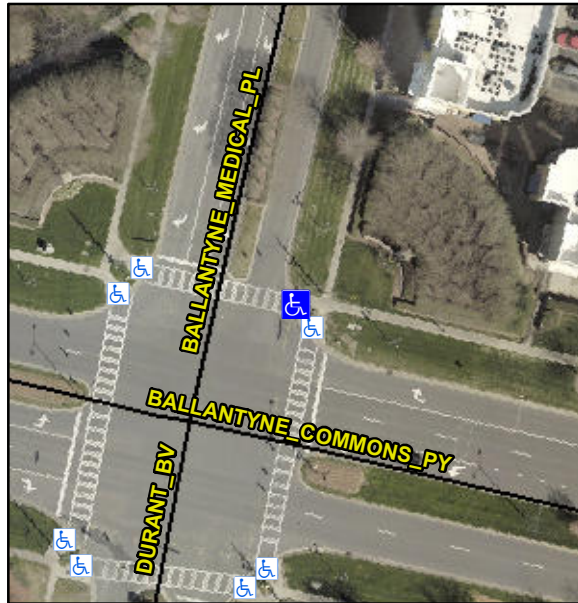
Not Found, R304.2.2, R304.5.3

Compliance	Description	Data	Compliance	Description	Data
N/A	Ramp Length (in)	128.0	No	Ramp Slope (%)	10.4
Yes	Ramp Width (in)	48.0	No	Ramp XSlope (%)	12.4
N/A	Flare Type LT	N/A	N/A	Flare Type RT	N/A
N/A	Flare Slope LT (%)	N/A	N/A	Flare Slope RT (%)	N/A
N/A	Flare Traversable LT?	N/A	N/A	Flare Traversable RT?	N/A
N/A	Landing Length (in)	N/A	N/A	DWS Provided?	N/A
N/A	Landing Width (in)	N/A	N/A	DWS Contrast?	N/A
N/A	Landing Slope (%)	N/A	N/A	DWS Length (in)	N/A
N/A	Landing X Slope (%)	N/A	N/A	DWS Full Width?	N/A
N/A	Landing Curb? (Y/N)	N/A	N/A	DWS Offset (in)	N/A
N/A	Shared Landing?	N/A			
N/A	Gutter Ponding?	N/A	N/A	Gutter Slope (%)	N/A
N/A	Gutter Lip Ht (in)	N/A	N/A	Gutter X Slope (%)	N/A
N/A	Painted X Walk1?	Yes	N/A	Painted X Walk2?	N/A
	X Walk 1 Direction	To W		X Walk 2 Direction	N/A
N/A	X Walk 1 Width (in)	125.0	N/A	X Walk 2 Width (in)	N/A
	X Walk 1 Slope (%)	2.8		X Walk 2 Slope (%)	N/A
	X Walk 1 X Slope (%)	7.3		X Walk 2 X Slope (%)	N/A

N/A	Ramp inside XWalk1?	Yes	N/A	Ramp inside XWalk2?	N/A
	Road Slope (%)	N/A	N/A	Clear Space?	N/A
	Road X Slope (%)	N/A	N/A	Clear Space to XWalk (in)	N/A
N/A	Any Obstructions?	N/A	N/A	Storm Grate/Utility Hazard?	N/A
	Obstruction Type			Storm Grate/Utility Type	
		N/A			N/A
		Yes		Surface Condition? (G/P)	Good

Possible Solutions:

Remove & Replace Entire Ramp.
