Access Compliance Report

Public Rights-of-Way

(Curb Ramps)

Intersection ID: 2908	Main Street: CORNER_CT	Cross Street: MEADOWVIEW_HILLS_DR	Location: NW
ADA ID: 03A453F9D810	Ramp Type: PerpDiag	Initial Pass/Fail: Fail	Overall Compliance: No
Severity Score: 35			
Codes/Mitigation Info/Possible Solution		Field Measurements/Component Compliance

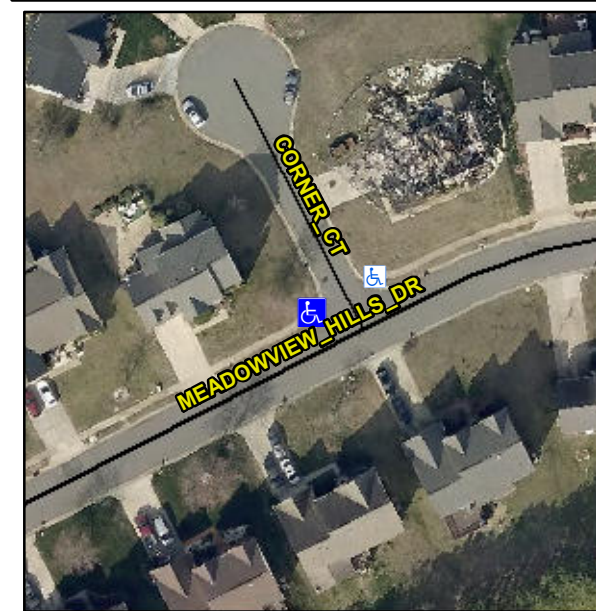
Not Found, R304.5.1, R304.2.2, R304.5.3

Compliance	Description	Data	Compliance	Description	Data
N/A	Ramp Length (in)	40.0	No	Ramp Slope (%)	15.7
No	Ramp Width (in)	38.0	No	Ramp XSlope (%)	2.8
N/A	Flare Type LT	N/A	N/A	Flare Type RT	N/A
N/A	Flare Slope LT (%)	N/A	N/A	Flare Slope RT (%)	N/A
N/A	Flare Traversable LT?	N/A	N/A	Flare Traversable RT?	N/A
N/A	Landing Length (in)	N/A	N/A	DWS Provided?	N/A
N/A	Landing Width (in)	N/A	N/A	DWS Contrast?	N/A
N/A	Landing Slope (%)	N/A	N/A	DWS Length (in)	N/A
N/A	Landing X Slope (%)	N/A	N/A	DWS Full Width?	N/A
N/A	Landing Curb? (Y/N)	N/A	N/A	DWS Offset (in)	N/A
N/A	Shared Landing?	N/A			
N/A	Gutter Ponding?	N/A	N/A	Gutter Slope (%)	N/A
N/A	Gutter Lip Ht (in)	N/A	N/A	Gutter X Slope (%)	N/A
N/A	Painted X Walk1?	No	N/A	Painted X Walk2?	No
	X Walk 1 Direction	To S		X Walk 2 Direction	To E
N/A	X Walk 1 Width (in)	N/A	N/A	X Walk 2 Width (in)	N/A
	X Walk 1 Slope (%)	3.0		X Walk 2 Slope (%)	4.1
	X Walk 1 X Slope (%)	0.1		X Walk 2 X Slope (%)	0.7

N/A	Ramp inside XWalk1?	N/A	N/A	Ramp inside XWalk2?	N/A
	Road Slope (%)	0.8	N/A	Clear Space?	N/A
	Road X Slope (%)	4.2	N/A	Clear Space to XWalk (in)	N/A
N/A	Any Obstructions?	N/A	N/A	Storm Grate/Utility Hazard?	N/A
	Obstruction Type			Storm Grate/Utility Type	
		N/A			N/A
			Yes	Surface Condition? (G/P)	Good

Possible Solutions:

Remove & Replace Curb Ramp With Two New Directional Ramps or Equivalent.
