Access Compliance Report

Public Rights-of-Way

(Curb Ramps)

Intersection ID: N/A	Main Street: TAMARACK DR	Cross Street: SINGLELEAF LN	Location: N
ADA ID: 03AC5DB5D824	Ramp Type: Perp	Initial Pass/Fail: Fail	Overall Compliance: No
Severity Score: 8.75			
Codes/Mitigation Info/Possible Solution		Field Measurements/Component Compliance

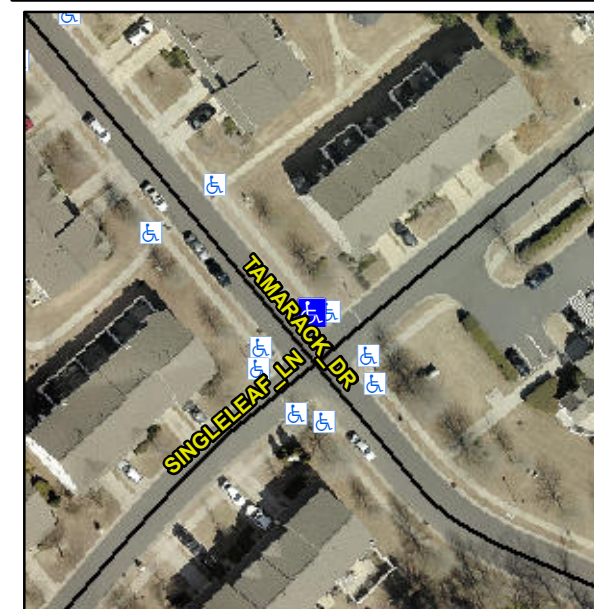
Not Found, R304.5.1

Compliance	Description	Data	Compliance	Description	Data
N/A	Ramp Length (in)	48.0	Yes	Ramp Slope (%)	7.2
No	Ramp Width (in)	46.0	Yes	Ramp XSlope (%)	0.7
N/A	Flare Type LT	N/A	N/A	Flare Type RT	N/A
N/A	Flare Slope LT (%)	N/A	N/A	Flare Slope RT (%)	N/A
N/A	Flare Traversable LT?	No	N/A	Flare Traversable RT?	No
N/A	Landing Length (in)	N/A	N/A	DWS Provided?	N/A
N/A	Landing Width (in)	N/A	N/A	DWS Contrast?	N/A
N/A	Landing Slope (%)	N/A	N/A	DWS Length (in)	N/A
N/A	Landing X Slope (%)	N/A	N/A	DWS Full Width?	N/A
N/A	Landing Curb? (Y/N)	N/A	N/A	DWS Offset (in)	N/A
N/A	Shared Landing?	N/A			
N/A	Gutter Ponding?	N/A	N/A	Gutter Slope (%)	N/A
N/A	Gutter Lip Ht (in)	N/A	N/A	Gutter X Slope (%)	N/A
N/A	Painted X Walk1?	No	N/A	Painted X Walk2?	N/A
	X Walk 1 Direction	To SW		X Walk 2 Direction	N/A
N/A	X Walk 1 Width (in)	N/A	N/A	X Walk 2 Width (in)	N/A
	X Walk 1 Slope (%)	0.8		X Walk 2 Slope (%)	N/A
	X Walk 1 X Slope (%)	0.3		X Walk 2 X Slope (%)	N/A

N/A	Ramp inside XWalk1?	No	N/A	Ramp inside XWalk2?	N/A
	Road Slope (%)	N/A	N/A	Clear Space?	N/A
	Road X Slope (%)	N/A	N/A	Clear Space to XWalk (in)	N/A
N/A	Any Obstructions?	N/A	N/A	Storm Grate/Utility Hazard?	N/A
	Obstruction Type			Storm Grate/Utility Type	
		N/A			N/A
			Yes	Surface Condition? (G/P)	Good

Remove & Replace Entire Ramp.
