# Access Compliance Report

## Public Rights-of-Way

| Intersection ID: 19251 | Main Street: CHERRY_TRIPP_DR | Cross Street: VILLAGE_LAKE_DR | Location: SW |
| ADA ID: 03AEFFE8EF40 | Ramp Type: PerpDiag | Initial Pass/Fail: Fail | Overall Compliance: No |

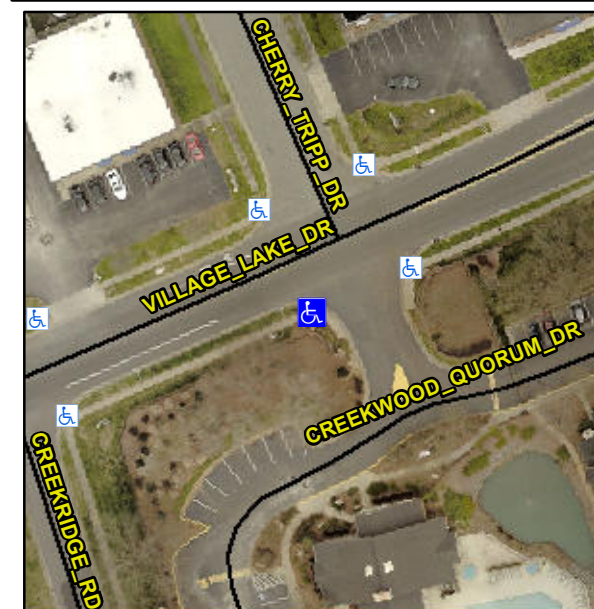
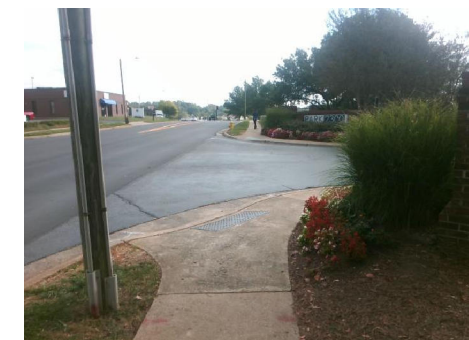
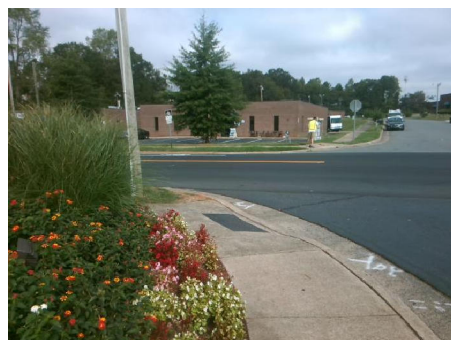
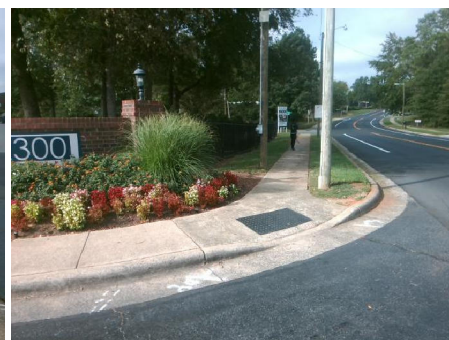
| Severity Score: 26.25 | | | |

**R304.2.2, R304.5.3**

| Compliance | Description | Data | Compliance | Description | Data |
|---|---|---|---|---|---|
| N/A | Ramp Length (in) | 60.0 | No | Ramp Slope (%) | 14.9 |
| Yes | Ramp Width (in) | 48.0 | No | Ramp XSlope (%) | 3.1 |

**Remove & Replace Curb Ramp With Two New Directional Ramps or Equivalent.**

Total Cost: \$ 3200.00
