Access Compliance Report Public Rights-of-Way (Curb Ramps)

Intersection ID: 10439 Main Street: N_TRYON_ST Cross Street: W_24TH_ST Location: W ADA ID: 03BA33CE50E8 Ramp Type: PerpDiag Initial Pass/Fail: Fail **Overall Compliance: No Severity Score:** 22.5

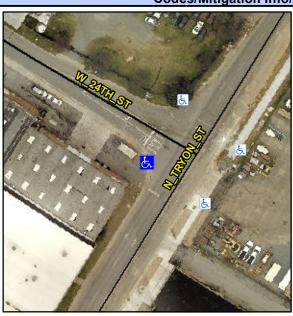
Field Measurements/Component Compliance					
Compliance Description		Data	Compliance Description		Data
N/A	Ramp Length (in)	60.0	No	Ramp Slope (%)	10.2
No	Ramp Width (in)	39.5	No	Ramp XSlope (%)	3.5
N/A	Flare Type LT	N/A	N/A	Flare Type RT	N/A
N/A	Flare Slope LT (%)	N/A	N/A	Flare Slope RT (%)	N/A
N/A	Flare Traversable LT?	N/A	N/A	Flare Traversable RT?	N/A
N/A	Landing Length (in)	N/A	N/A	DWS Provided?	N/A
N/A	Landing Width (in)	N/A	N/A	DWS Contrast?	N/A
N/A	Landing Slope (%)	N/A	N/A	DWS Length (in)	N/A
N/A	Landing X Slope (%)	N/A	N/A	DWS Full Width?	N/A
N/A	Landing Curb? (Y/N)	N/A	N/A	DWS Offset (in)	N/A
N/A	Shared Landing?	N/A			
N/A	Gutter Ponding?	N/A	N/A	Gutter Slope (%)	N/A
N/A	Gutter Lip Ht (in)	N/A	N/A	Gutter X Slope (%)	N/A
N/A	Painted X Walk1?	No	N/A	Painted X Walk2?	Yes
	X Walk 1 Direction	To SE		X Walk 2 Direction	To NE
N/A	X Walk 1 Width (in)	N/A	N/A	X Walk 2 Width (in)	111.0
	X Walk 1 Slope (%)	0.3		X Walk 2 Slope (%)	0.9

X Walk 1 X Slope (%)	0.4		X Walk 2 X Slope (%)	3.6
N/A	Ramp inside XWalk1?	N/A	N/A	Ramp inside XWalk2?	Yes
	Road Slope (%)	2.3	N/A	Clear Space?	N/A
	Road X Slope (%)	0.5	N/A	Clear Space to XWalk (in)	N/A
N/A	Any Obstructions?	N/A	N/A	Storm Grate/Utility Hazard?	N/A
	Obstruction Type			Storm Grate/Utility Type	
		N/A			N/A
			Yes	Surface Condition? (G/P)	Good
	1 A 18 CONST. CONST.

Possible Solutions: Remove & Replace Curb Ramp With **Two New Directional Ramps or** Equivalent.

Surveyor Notes: PROW/ADA: Not Found, R304.5.1, R304.2.2, R304.5.3
