Access Compliance Report

Public Rights-of-Way

(Curb Ramps)

Intersection ID: 20234	Main Street: SHOPTON_RD_WEST	Cross Street: WITHERS_RD	Location: NE
ADA ID: 03C41F3600EE	Ramp Type: BlendTrans2	Initial Pass/Fail: Fail	Overall Compliance: No
		Severity Score: 12.5

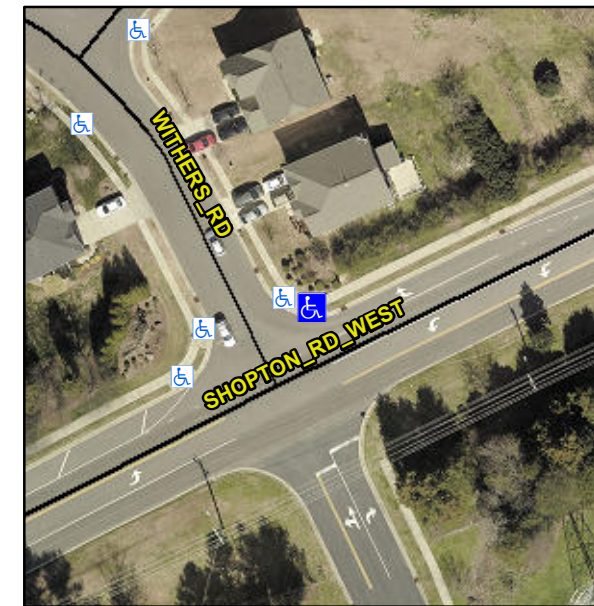
LT RP < 5%

Compliance	Description	Data	Compliance	Description	Data
N/A	Ramp Length (in)	47.0	Yes	BlendTrans Slope (%)	3.6
Yes	Ramp Width (in)	48.0	No	BlendTrans XSlope (%)	5.8
N/A	Flare Type LT	N/A	N/A	Flare Type RT	N/A
N/A	Flare Slope LT (%)	N/A	N/A	Flare Slope RT (%)	N/A
N/A	Flare Traversable LT?	N/A	N/A	Flare Traversable RT?	N/A
N/A	Landing Length (in)	N/A	N/A	DWS Provided?	N/A
N/A	Landing Width (in)	N/A	N/A	DWS Contrast?	N/A
N/A	Landing Slope (%)	N/A	N/A	DWS Length (in)	N/A
N/A	Landing X Slope (%)	N/A	N/A	DWS Full Width?	N/A
N/A	Landing Curb? (Y/N)	N/A	N/A	DWS Offset (in)	N/A
N/A	Shared Landing?	N/A			
N/A	Gutter Ponding?	N/A	N/A	Gutter Slope (%)	N/A
N/A	Gutter Lip Ht (in)	N/A	N/A	Gutter X Slope (%)	N/A
N/A	Painted X Walk1?	No	N/A	Painted X Walk2?	N/A
	X Walk 1 Direction	To SE		X Walk 2 Direction	N/A
	X Walk 1 Width (in)	N/A		X Walk 2 Width (in)	N/A
	X Walk 1 Slope (%)	0.2		X Walk 2 Slope (%)	N/A
	X Walk 1 X Slope (%)	3.6		X Walk 2 X Slope (%)	N/A

N/A	Ramp inside XWalk1?	N/A	N/A	Ramp inside XWalk2?	N/A
	Road Slope (%)	3.6		Clear Space?	N/A
	Road X Slope (%)	0.2	N/A	Clear Space to XWalk (in)	N/A
N/A	Any Obstructions?	N/A	N/A	Storm Grate/Utility Hazard?	N/A
	Obstruction Type			Storm Grate/Utility Type	
		N/A			N/A
			Yes	Surface Condition? (G/P)	Good
			N/A	Curb Slope (%)	1.0

Remove & Replace Curb Ramp With Two New Directional Ramps or Equivalent.
