# Access Compliance Report

## Public Rights-of-Way

| Intersection ID: 44305 | Main Street: VALERIE_DR | Cross Street: MALLORY_TAYLOR_LN | Location: SE |
| ADA ID: 03C76BCBBC8D | Ramp Type: BlendTrans1 | Initial Pass/Fail: Fail | Overall Compliance: No |

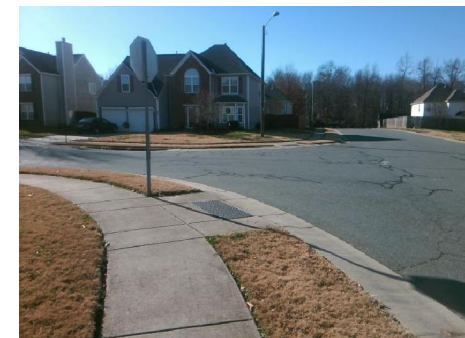
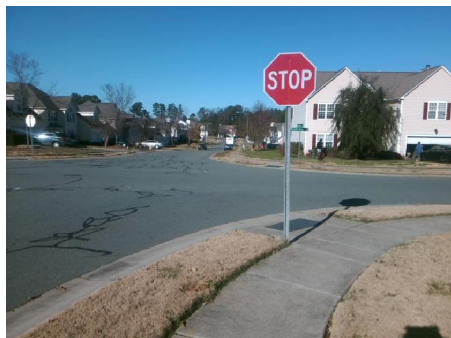
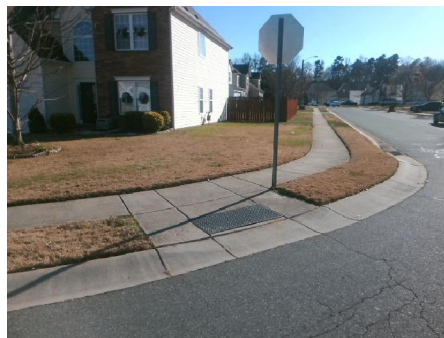
**Not Found, R304.5.1, R304.5.3**

| Compliance | Description | Data | Compliance | Description | Data |
|---|---|---|---|---|---|
| No | Ramp Width (in) | 45.5 | No | BlendTrans XSlope (%) | 4.1 |
| | | | No | Curb Slope (%) | 16.2 |

**Remove & Replace Curb Ramp With Two New Directional Ramps or Equivalent.**
