Access Compliance Report

Public Rights-of-Way

(Curb Ramps)

Intersection ID: 8940	Main Street: LUDWIG_DR	Cross Street: PENTLOW_PL	Location:	N
ADA ID: 03D30FE20F49	Ramp Type: BlendTrans2	Initial Pass/Fail: Fail	Overall Compliance: No	Severity Score: 12.5
Codes/Mitigation Info/Possible Solution		Field Measurements/Component Compliance

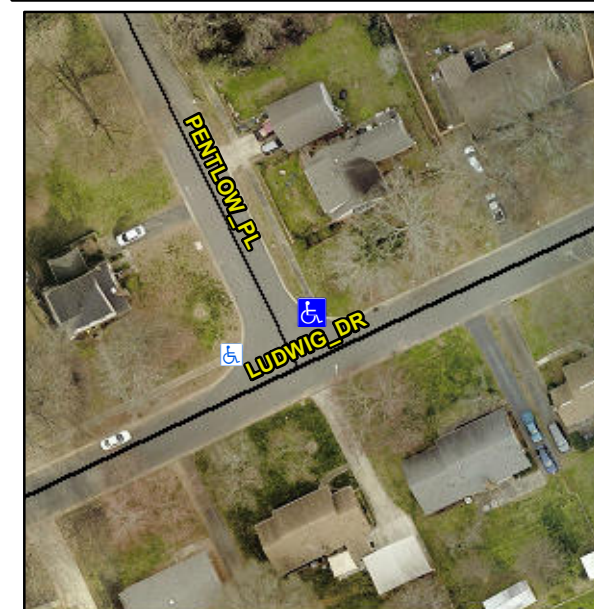
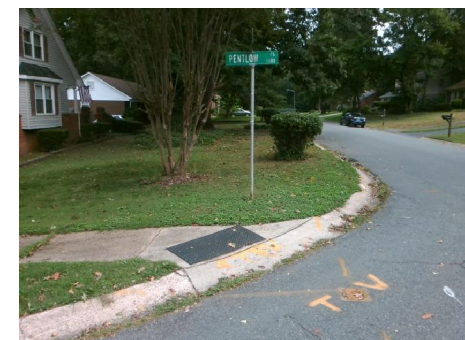
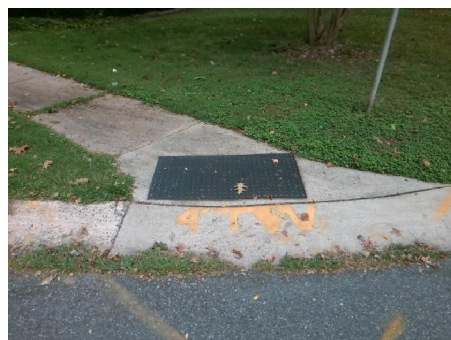
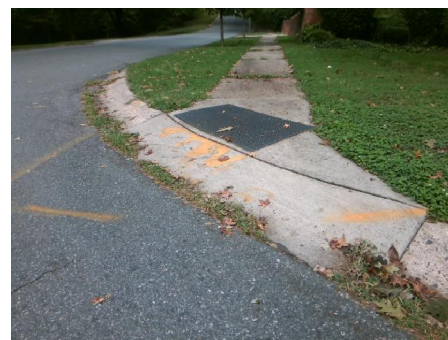
Not Found, R304.5.3

Compliance	Description	Data	Compliance	Description	Data
N/A	Ramp Length (in)	30.0	Yes	BlendTrans Slope (%)	1.1
Yes	Ramp Width (in)	48.0	No	BlendTrans XSlope (%)	5.5
N/A	Flare Type LT	N/A	N/A	Flare Type RT	N/A
N/A	Flare Slope LT (%)	N/A	N/A	Flare Slope RT (%)	N/A
N/A	Flare Traversable LT?	N/A	N/A	Flare Traversable RT?	N/A
N/A	Landing Length (in)	N/A	N/A	DWS Provided?	N/A
N/A	Landing Width (in)	N/A	N/A	DWS Contrast?	N/A
N/A	Landing Slope (%)	N/A	N/A	DWS Length (in)	N/A
N/A	Landing X Slope (%)	N/A	N/A	DWS Full Width?	N/A
N/A	Landing Curb? (Y/N)	N/A	N/A	DWS Offset (in)	N/A
N/A	Shared Landing?	N/A			
N/A	Gutter Ponding?	N/A	N/A	Gutter Slope (%)	N/A
N/A	Gutter Lip Ht (in)	1.0	N/A	Gutter X Slope (%)	N/A
N/A	Painted X Walk1?	No	N/A	Painted X Walk2?	N/A
	X Walk 1 Direction	To SW		X Walk 2 Direction	N/A
	X Walk 1 Width (in)	N/A		X Walk 2 Width (in)	N/A
	X Walk 1 Slope (%)	1.3		X Walk 2 Slope (%)	N/A
	X Walk 1 X Slope (%)	6.0		X Walk 2 X Slope (%)	N/A

N/A	Ramp inside XWalk1?	N/A	N/A	Ramp inside XWalk2?	N/A
	Road Slope (%)	6.0		Clear Space?	N/A
	Road X Slope (%)	1.3	N/A	Clear Space to XWalk (in)	N/A
N/A	Any Obstructions?	N/A	N/A	Storm Grate/Utility Hazard?	N/A
	Obstruction Type			Storm Grate/Utility Type	
		N/A			N/A
			Yes	Surface Condition? (G/P)	Good
			No	Curb Slope (%)	25.8

Possible Solutions:

Remove & Replace Curb Ramp With Two New Directional Ramps or Equivalent.
