Access Compliance Report

Public Rights-of-Way

(Curb Ramps)

Intersection ID: 50344	Main Street: KELBURN_LN	Cross Street: FENWAY_DR	Location: SE
ADA ID: 03DD0C486172	Ramp Type: Perp	Initial Pass/Fail: Fail	Overall Compliance: No
Codes/Mitigation Info/Possible Solution		Field Measurements/Component Compliance	
Severity Score: 8.75

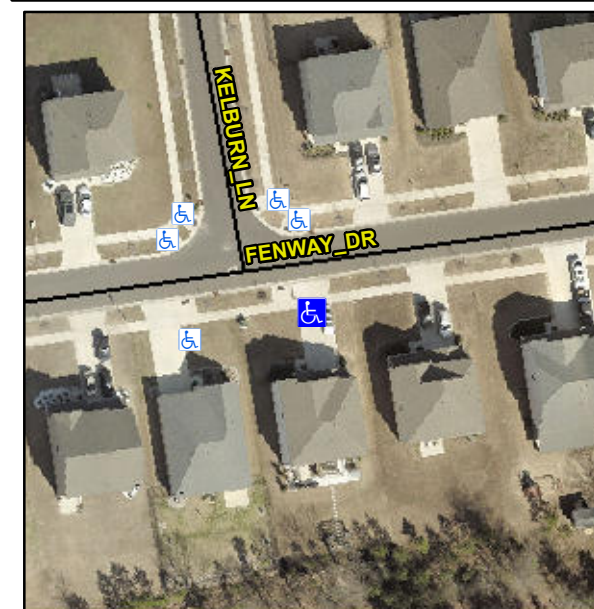
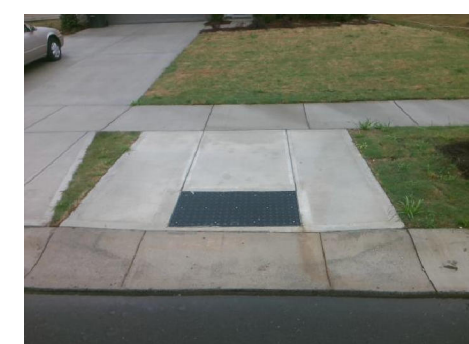
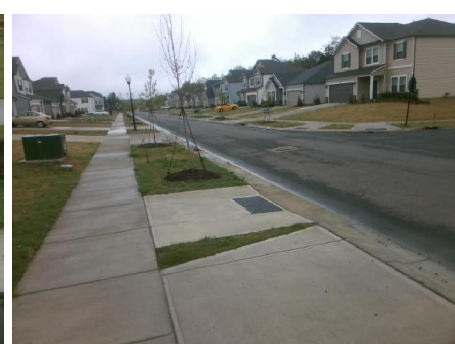
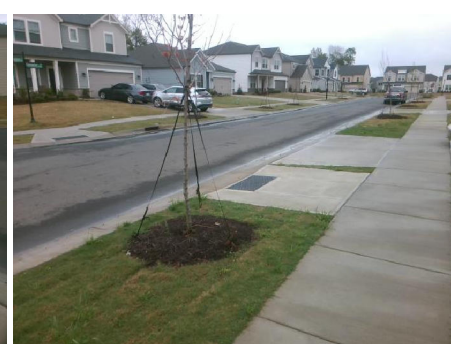
Compliance	Description	Data	Compliance	Description	Data
N/A	Ramp Length (in)	95.0	Yes	Ramp Slope (%)	7.4
No	Ramp Width (in)	47.0	Yes	Ramp XSlope (%)	0.8
N/A	Flare Type LT	N/A	N/A	Flare Type RT	N/A
N/A	Flare Slope LT (%)	N/A	N/A	Flare Slope RT (%)	N/A
N/A	Flare Traversable LT?	N/A	N/A	Flare Traversable RT?	N/A
N/A	Landing Length (in)	N/A	N/A	DWS Provided?	N/A
N/A	Landing Width (in)	N/A	N/A	DWS Contrast?	N/A
N/A	Landing Slope (%)	N/A	N/A	DWS Length (in)	N/A
N/A	Landing X Slope (%)	N/A	N/A	DWS Full Width?	N/A
N/A	Landing Curb? (Y/N)	N/A	N/A	DWS Offset (in)	N/A
N/A	Shared Landing?	N/A			
N/A	Gutter Ponding?	N/A	N/A	Gutter Slope (%)	N/A
N/A	Gutter Lip Ht (in)	1.0	N/A	Gutter X Slope (%)	N/A
N/A	Painted X Walk1?	No	N/A	Painted X Walk2?	N/A
	X Walk 1 Direction	To N		X Walk 2 Direction	N/A
N/A	X Walk 1 Width (in)	N/A	N/A	X Walk 2 Width (in)	N/A
	X Walk 1 Slope (%)	4.9		X Walk 2 Slope (%)	N/A
	X Walk 1 X Slope (%)	1.4		X Walk 2 X Slope (%)	N/A

N/A	Ramp inside XWalk1?	N/A	N/A	Ramp inside XWalk2?	N/A
	Road Slope (%)	N/A	N/A	Clear Space?	N/A
	Road X Slope (%)	N/A	N/A	Clear Space to XWalk (in)	N/A
N/A	Any Obstructions?	N/A	N/A	Storm Grate/Utility Hazard?	N/A
	Obstruction Type			Storm Grate/Utility Type	
		N/A			N/A
		Yes		Surface Condition? (G/P)	Good

Remove & Replace Entire Ramp.

R304.5.1
