Access Compliance Report

Public Rights-of-Way

(Curb Ramps)

Intersection ID: 11610	Main Street: COLE_DR	Cross Street: GLENVILLE_AV	Location: SE
ADA ID: 03E3D968271E	Ramp Type: PerpDiag	Initial Pass/Fail: Fail	Overall Compliance: No
Severity Score: 12.5			
Codes/Mitigation Info/Possible Solution		Field Measurements/Component Compliance

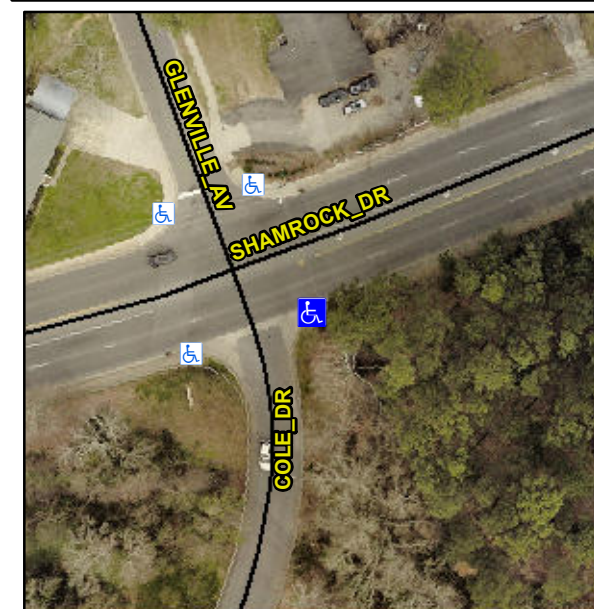
Not Found, R304.2.2

Compliance	Description	Data	Compliance	Description	Data
N/A	Ramp Length (in)	60.0	No	Ramp Slope (%)	8.6
Yes	Ramp Width (in)	48.0	Yes	Ramp XSlope (%)	0.2
N/A	Flare Type LT	N/A	N/A	Flare Type RT	N/A
N/A	Flare Slope LT (%)	N/A	N/A	Flare Slope RT (%)	N/A
N/A	Flare Traversable LT?	N/A	N/A	Flare Traversable RT?	N/A
N/A	Landing Length (in)	N/A	N/A	DWS Provided?	N/A
N/A	Landing Width (in)	N/A	N/A	DWS Contrast?	N/A
N/A	Landing Slope (%)	N/A	N/A	DWS Length (in)	N/A
N/A	Landing X Slope (%)	N/A	N/A	DWS Full Width?	N/A
N/A	Landing Curb? (Y/N)	N/A	N/A	DWS Offset (in)	N/A
N/A	Shared Landing?	N/A			
N/A	Gutter Ponding?	N/A	N/A	Gutter Slope (%)	N/A
N/A	Gutter Lip Ht (in)	N/A	N/A	Gutter X Slope (%)	N/A
N/A	Painted X Walk1?	No	N/A	Painted X Walk2?	No
	X Walk 1 Direction	To N		X Walk 2 Direction	To W
N/A	X Walk 1 Width (in)	N/A	N/A	X Walk 2 Width (in)	N/A
	X Walk 1 Slope (%)	2.2		X Walk 2 Slope (%)	1.6
	X Walk 1 X Slope (%)	2.3		X Walk 2 X Slope (%)	2.1

N/A	Ramp inside XWalk1?	N/A	N/A	Ramp inside XWalk2?	N/A
	Road Slope (%)	2.4	N/A	Clear Space?	N/A
	Road X Slope (%)	2.4	N/A	Clear Space to XWalk (in)	N/A
N/A	Any Obstructions?	N/A	N/A	Storm Grate/Utility Hazard?	N/A
	Obstruction Type			Storm Grate/Utility Type	
		N/A			N/A
			Yes	Surface Condition? (G/P)	Good

Remove & Replace Curb Ramp With Two New Directional Ramps or Equivalent.
