Access Compliance Report

Public Rights-of-Way

(Curb Ramps)

Intersection ID: 32319	Main Street: ARDREY_KELL_RD	Cross Street: BRIDGEVIEW_LN	Location: NW
ADA ID: 03E6DE604983	Ramp Type: Perp	Initial Pass/Fail: Fail	Overall Compliance: No
			Severity Score: 21.25

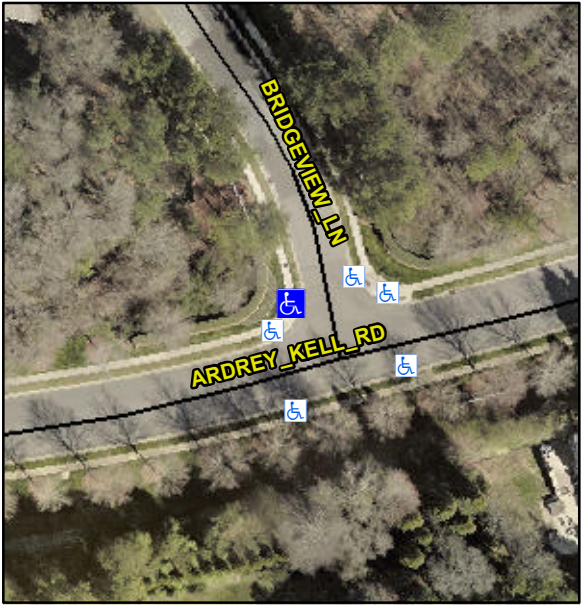
Possible Solutions:		Compliance	Description	Data	
	Remove & Replace Entire Ramp.		N/A	Ramp Length (in)	52.0	No
			No	Ramp Width (in)	44.5	Yes
			N/A	Flare Type LT	N/A	N/A
			N/A	Flare Slope LT (%)	N/A	N/A
			N/A	Flare Traversable LT?	N/A	N/A
			N/A	Landing Length (in)	N/A	N/A
			N/A	Landing Width (in)	N/A	N/A
			N/A	Landing Slope (%)	N/A	N/A
			N/A	Landing X Slope (%)	N/A	N/A
<p>Surveyor Notes:</p> <p>N/A</p> <p>PROW/ADA:</p> <p>Not Found, R304.5.1, R304.2.2</p>			N/A	Flare Type RT	N/A	N/A
			N/A	Flare Slope RT (%)	N/A	N/A
			N/A	Flare Traversable RT?	N/A	N/A
			N/A	DWS Provided?	N/A	N/A
			N/A	DWS Contrast?	N/A	N/A
			N/A	DWS Length (in)	N/A	N/A
			N/A	DWS Full Width?	N/A	N/A
			N/A	DWS Offset (in)	N/A	N/A
			N/A	Gutter Ponding?	N/A	N/A
			N/A	Gutter Lip Ht (in)	N/A	N/A
<p>Street 1 Name</p> <p>Stop Condition-Street 2</p> <p>Street 2 Name</p> <p>Stop Condition-Street 1</p>			No	Painted X Walk1?	N/A	N/A

X Walk 1 Direction	To E	N/A
			N/A	X Walk 1 Width (in)	N/A	N/A
				X Walk 1 Slope (%)	4.2	N/A
				X Walk 1 X Slope (%)	4.9	N/A
			N/A	Ramp inside XWalk1?	N/A	N/A
			N/A	Road Slope (%)	N/A	N/A
			N/A	Road X Slope (%)	N/A	N/A
			N/A	Any Obstructions?	N/A	N/A
				Obstruction Type		N/A
Total Cost:		\$ 1850.00				N/A
			Yes	Surface Condition? (G/P)		Good
