Access Compliance Report

Public Rights-of-Way

(Curb Ramps)

Intersection ID: 48772	Main Street: SONOMA_VALLEY_DR	Cross Street: LUMBER_LN	Location: NE
ADA ID: 03EB5A495C5B	Ramp Type: PerpDiag	Initial Pass/Fail: Fail	Overall Compliance: No
Codes/Mitigation Info/Possible Solution		Field Measurements/Component Compliance	
Severity Score: 12.5

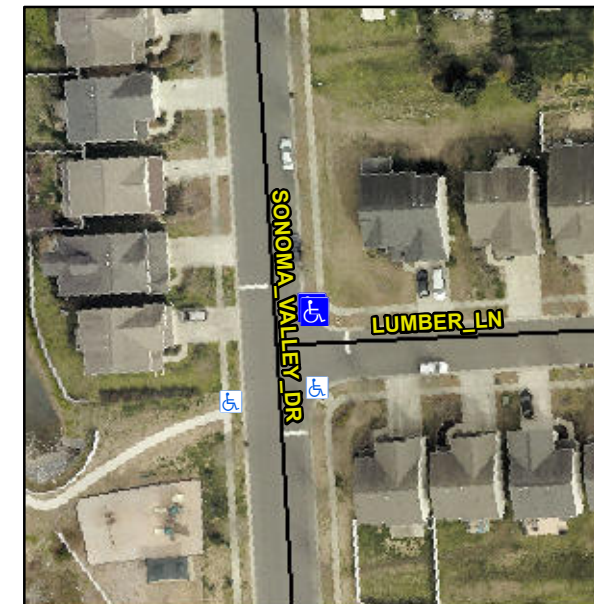
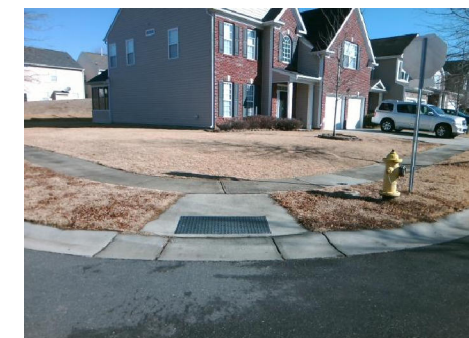
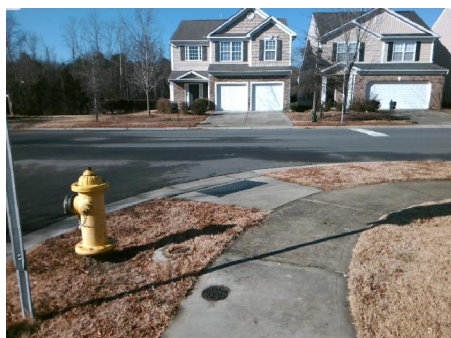
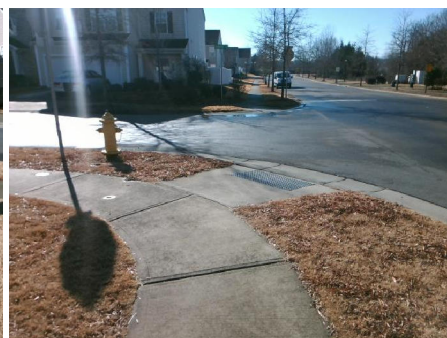
Not Found, R304.2.2

Compliance	Description	Data	Compliance	Description	Data
N/A	Ramp Length (in)	72.5	No	Ramp Slope (%)	9.4
Yes	Ramp Width (in)	48.0	Yes	Ramp XSlope (%)	1.3
N/A	Flare Type LT	N/A	N/A	Flare Type RT	N/A
N/A	Flare Slope LT (%)	N/A	N/A	Flare Slope RT (%)	N/A
N/A	Flare Traversable LT?	N/A	N/A	Flare Traversable RT?	N/A
N/A	Landing Length (in)	N/A	N/A	DWS Provided?	N/A
N/A	Landing Width (in)	N/A	N/A	DWS Contrast?	N/A
N/A	Landing Slope (%)	N/A	N/A	DWS Length (in)	N/A
N/A	Landing X Slope (%)	N/A	N/A	DWS Full Width?	N/A
N/A	Landing Curb? (Y/N)	N/A	N/A	DWS Offset (in)	N/A
N/A	Shared Landing?	N/A			
N/A	Gutter Ponding?	N/A	N/A	Gutter Slope (%)	N/A
N/A	Gutter Lip Ht (in)	N/A	N/A	Gutter X Slope (%)	N/A
N/A	Painted X Walk1?	No	N/A	Painted X Walk2?	No
	X Walk 1 Direction	To W		X Walk 2 Direction	To S
N/A	X Walk 1 Width (in)	N/A	N/A	X Walk 2 Width (in)	N/A
	X Walk 1 Slope (%)	0.3		X Walk 2 Slope (%)	0.2
	X Walk 1 X Slope (%)	1.8		X Walk 2 X Slope (%)	1.8

N/A	Ramp inside XWalk1?	N/A	N/A	Ramp inside XWalk2?	N/A
	Road Slope (%)	1.8	N/A	Clear Space?	N/A
	Road X Slope (%)	0.3	N/A	Clear Space to XWalk (in)	N/A
N/A	Any Obstructions?	N/A	N/A	Storm Grate/Utility Hazard?	N/A
	Obstruction Type			Storm Grate/Utility Type	
		N/A			N/A
		Yes		Surface Condition? (G/P)	Good

Remove & Replace Curb Ramp With Two New Directional Ramps or Equivalent.
