Access Compliance Report

Public Rights-of-Way

(Curb Ramps)

Intersection ID: 10041433	Main Street: WESTINGHOUSE_BV	Cross Street: N/A	Location: SE
ADA ID: 03F70B872C47	Ramp Type: PerpDiag	Initial Pass/Fail: Fail	Overall Compliance: No
Severity Score: 21.25			
Codes/Mitigation Info/Possible Solution		Field Measurements/Component Compliance

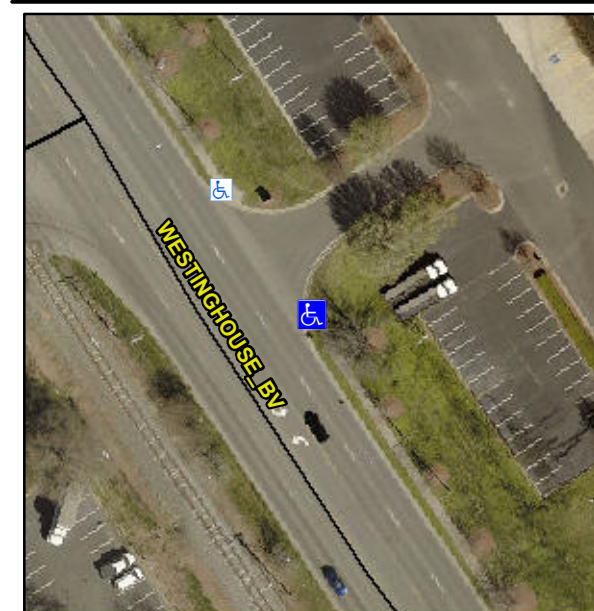
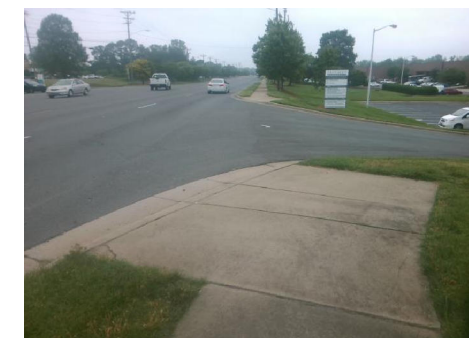
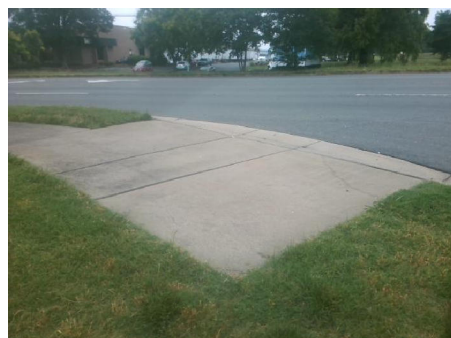
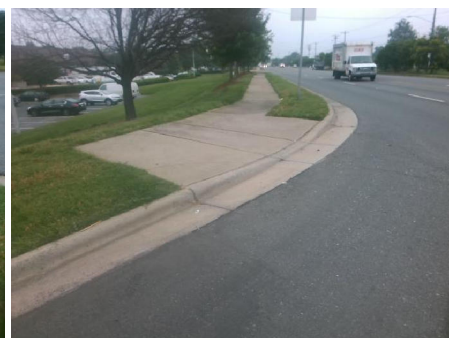
Compliance	Description	Data	Compliance	Description	Data
N/A	Ramp Length (in)	86.0	Yes	Ramp Slope (%)	5.2
No	Ramp Width (in)	38.0	No	Ramp XSlope (%)	6.2
N/A	Flare Type LT	N/A	N/A	Flare Type RT	N/A
N/A	Flare Slope LT (%)	N/A	N/A	Flare Slope RT (%)	N/A
N/A	Flare Traversable LT?	N/A	N/A	Flare Traversable RT?	N/A
N/A	Landing Length (in)	N/A	N/A	DWS Provided?	N/A
N/A	Landing Width (in)	N/A	N/A	DWS Contrast?	N/A
N/A	Landing Slope (%)	N/A	N/A	DWS Length (in)	N/A
N/A	Landing X Slope (%)	N/A	N/A	DWS Full Width?	N/A
N/A	Landing Curb? (Y/N)	N/A	N/A	DWS Offset (in)	N/A
N/A	Shared Landing?	N/A			
N/A	Gutter Ponding?	N/A	N/A	Gutter Slope (%)	N/A
N/A	Gutter Lip Ht (in)	N/A	N/A	Gutter X Slope (%)	N/A
N/A	Painted X Walk1?	No	N/A	Painted X Walk2?	No
	X Walk 1 Direction	To N		X Walk 2 Direction	To W
N/A	X Walk 1 Width (in)	N/A	N/A	X Walk 2 Width (in)	N/A
	X Walk 1 Slope (%)	1.6		X Walk 2 Slope (%)	1.5
	X Walk 1 X Slope (%)	3.7		X Walk 2 X Slope (%)	0.3

N/A	Ramp inside XWalk1?	N/A	N/A	Ramp inside XWalk2?	N/A
	Road Slope (%)	1.8	N/A	Clear Space?	N/A
	Road X Slope (%)	0.4	N/A	Clear Space to XWalk (in)	N/A
N/A	Any Obstructions?	N/A	N/A	Storm Grate/Utility Hazard?	N/A
	Obstruction Type			Storm Grate/Utility Type	
		N/A			N/A
		Yes		Surface Condition? (G/P)	Good

Remove & Replace Curb Ramp With Two New Directional Ramps or Equivalent.

R304.5.1, R304.5.3
