# Access Compliance Report

## Public Rights-of-Way

### (Curb Ramps)

| Intersection ID: 9099 | Main Street: DEWOLFE_ST | Cross Street: JOYCETON_ST | Location: NE |

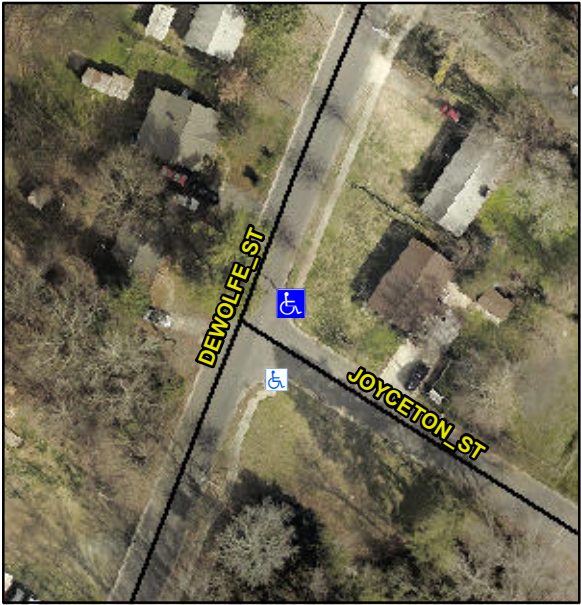
| ADA ID: 040A25A9C7E6 | Ramp Type: Perp | Initial Pass/Fail: Fail | Overall Compliance: No |

| Codes/Mitigation Info/Possible Solution | | | Field Measurements/Component Compliance | | |
|---|---|--|---|---|---|
| | | | <b>No</b> | Ramp Width (in) | 48.0 |
| <p>PROW/ADA:</p> <p><b>Not Found, R304.5.3</b></p> | | | <b>N/A</b> | Road Slope (%) | N/A |

| Codes/Mitigation Info/Possible Solution | | | Field Measurements/Component Compliance | | |
|---|---|--|---|---|---|
| | <b>Remove &amp; Replace Entire Ramp.</b> | | <b>Yes</b> | Ramp Length (in) | 47.0 |
