# Access Compliance Report

## Public Rights-of-Way

### (Curb Ramps)

Intersection ID: 12220	Main Street: E_6TH_ST	Cross Street: N_COLLEGE_ST	Location: S
ADA ID: 041D4ADFB3A7	Ramp Type: Perp	Initial Pass/Fail: Fail	Overall Compliance: No
		Severity Score: 12.5

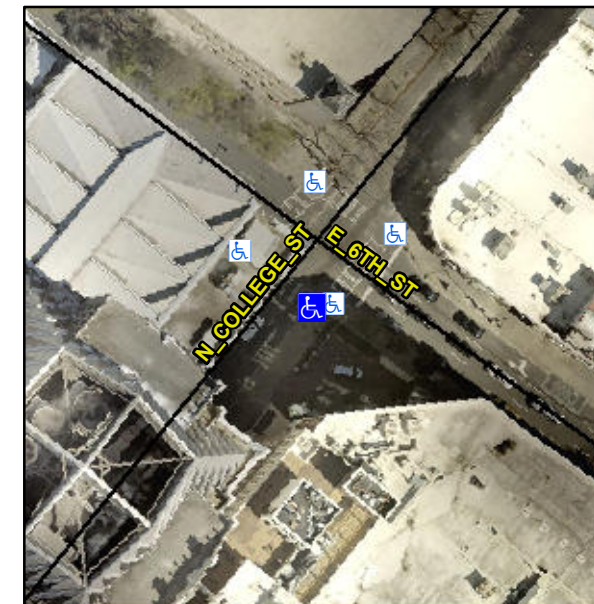
**Not Found, R304.2.2**

Compliance	Description	Data	Compliance	Description	Data
N/A	Ramp Length (in)	56.0	No	Ramp Slope (%)	9.0
Yes	Ramp Width (in)	48.0	Yes	Ramp XSlope (%)	1.7
N/A	Flare Type LT	N/A	N/A	Flare Type RT	N/A
N/A	Flare Slope LT (%)	N/A	N/A	Flare Slope RT (%)	N/A
N/A	Flare Traversable LT?	N/A	N/A	Flare Traversable RT?	N/A
N/A	Landing Length (in)	N/A	N/A	DWS Provided?	N/A
N/A	Landing Width (in)	N/A	N/A	DWS Contrast?	N/A
N/A	Landing Slope (%)	N/A	N/A	DWS Length (in)	N/A
N/A	Landing X Slope (%)	N/A	N/A	DWS Full Width?	N/A
N/A	Landing Curb? (Y/N)	N/A	N/A	DWS Offset (in)	N/A
N/A	Shared Landing?	N/A			
N/A	Gutter Ponding?	N/A	N/A	Gutter Slope (%)	N/A
N/A	Gutter Lip Ht (in)	N/A	N/A	Gutter X Slope (%)	N/A
N/A	Painted X Walk1?	Yes	N/A	Painted X Walk2?	N/A
	X Walk 1 Direction	To NW		X Walk 2 Direction	N/A
N/A	X Walk 1 Width (in)	110.0	N/A	X Walk 2 Width (in)	N/A
	X Walk 1 Slope (%)	4.1		X Walk 2 Slope (%)	N/A
	X Walk 1 X Slope (%)	3.0		X Walk 2 X Slope (%)	N/A

N/A	Ramp inside XWalk1?	Yes	N/A	Ramp inside XWalk2?	N/A
	Road Slope (%)	N/A	N/A	Clear Space?	N/A
	Road X Slope (%)	N/A	N/A	Clear Space to XWalk (in)	N/A
N/A	Any Obstructions?	N/A	N/A	Storm Grate/Utility Hazard?	N/A
	Obstruction Type			Storm Grate/Utility Type	
		N/A			N/A
			Yes	Surface Condition? (G/P)	Good

**Remove & Replace Entire Ramp.**

Total Cost: \$ 1850.00
