Access Compliance Report

Public Rights-of-Way

(Curb Ramps)

Intersection ID: 15466	Main Street: CHARLOTTE_DR	Cross Street: LEDGEWOOD_LN	Location: NW
ADA ID: 041E62D06072	Ramp Type: Directional1	Initial Pass/Fail: Fail	Overall Compliance: No
Severity Score: 1.25			
Codes/Mitigation Info/Possible Solution		Field Measurements/Component Compliance

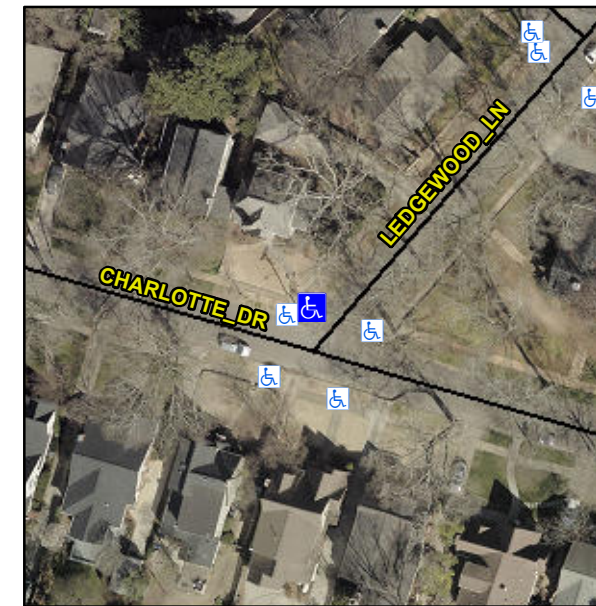
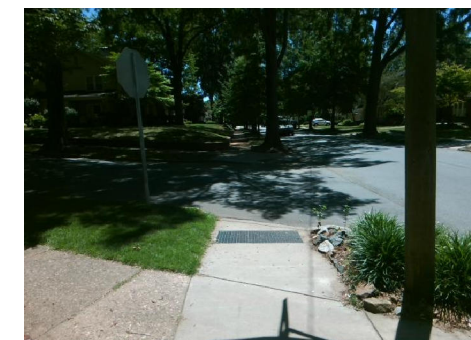
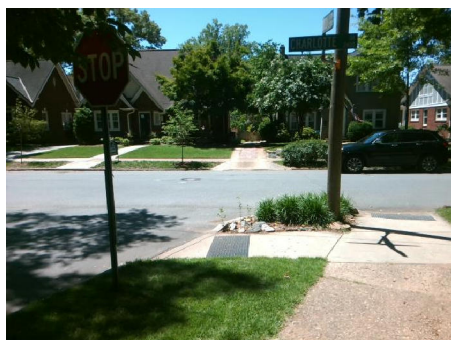
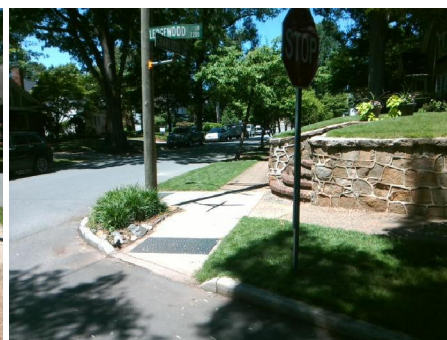
Compliance	Description	Data	Compliance	Description	Data
N/A	Ramp Length (in)	24.5	N/A	Grade Break?	N/A
Yes	Ramp Width (in)	60.0	N/A	Grade Break Slope (%)	0.0
Yes	Ramp Slope (%)	3.7	N/A	Grade Break XSlope (%)	0.0
No	Ramp XSlope (%)	4.3			
N/A	Flare Type LT	N/A	N/A	Flare Type RT	N/A
N/A	Flare Slope LT (%)	N/A	N/A	Flare Slope RT (%)	0.0
N/A	Flare Traversable LT?	N/A	N/A	Flare Traversable RT?	N/A
N/A	Landing Length (in)	0.0	N/A	DWS Provided?	N/A
N/A	Landing Width (in)	0.0	N/A	DWS Contrast?	N/A
N/A	Landing Slope (%)	0.0	N/A	DWS Length (in)	N/A
N/A	Landing X Slope (%)	0.0	N/A	DWS Full Width?	N/A
N/A	Landing Curb? (Y/N)	N/A	N/A	DWS Offset LT (in)	N/A
N/A	Shared Landing?	N/A	N/A	DWS Offset RT (in)	N/A
N/A	Gutter Ponding?	0.0	N/A	Gutter Slope (%)	N/A
N/A	Gutter Lip Ht (in)	1.0	N/A	Gutter X Slope (%)	N/A
N/A	Painted X Walk1?	No		Road Slope (%)	2.5
	X Walk 1 Direction	To E		Road X Slope (%)	2.6
	X Walk 1 Width (in)	N/A		Clear Space?	N/A

X Walk 1 Slope (%)	2.5	N/A	Clear Space to XWalk (in)	N/A
	X Walk 1 X Slope (%)	2.6	N/A	Storm Grate/Utility Hazard?	N/A
N/A	Ramp inside XWalk1?	N/A		Storm Grate/Utility Type	
N/A	Any Obstructions?	N/A			N/A
	Obstruction Type		Yes	Surface Condition? (G/P)	Good
			N/A	Curb Slope (%)	3.6

Possible Solutions:

Remove & Replace Entire Ramp.
