# Access Compliance Report

## Public Rights-of-Way

### (Curb Ramps)

Intersection ID: 10036927	Main Street: S_SHARON_AMITY_RD	Cross Street: N/A	Location: NW
ADA ID: 04232A120A74	Ramp Type: PerpDiag	Initial Pass/Fail: Fail	Overall Compliance: No
Severity Score: 13.75			
Codes/Mitigation Info/Possible Solution		Field Measurements/Component Compliance

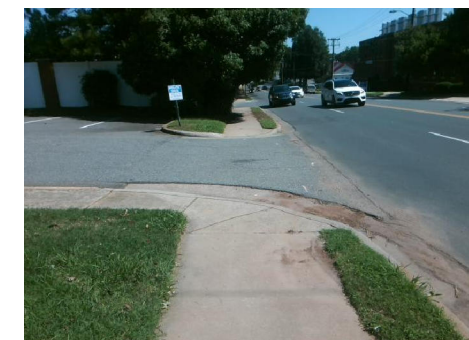
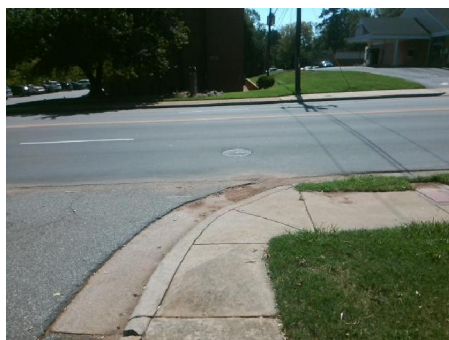
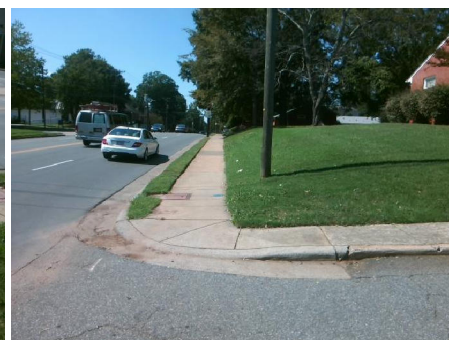
**Not Found, R304.2.2, R304.5.3**

Compliance	Description	Data	Compliance	Description	Data
N/A	Ramp Length (in)	55.0	No	Ramp Slope (%)	11.0
Yes	Ramp Width (in)	48.0	No	Ramp XSlope (%)	2.8
N/A	Flare Type LT	N/A	N/A	Flare Type RT	N/A
N/A	Flare Slope LT (%)	N/A	N/A	Flare Slope RT (%)	N/A
N/A	Flare Traversable LT?	N/A	N/A	Flare Traversable RT?	N/A
N/A	Landing Length (in)	N/A	N/A	DWS Provided?	N/A
N/A	Landing Width (in)	N/A	N/A	DWS Contrast?	N/A
N/A	Landing Slope (%)	N/A	N/A	DWS Length (in)	N/A
N/A	Landing X Slope (%)	N/A	N/A	DWS Full Width?	N/A
N/A	Landing Curb? (Y/N)	N/A	N/A	DWS Offset (in)	N/A
N/A	Shared Landing?	N/A			
N/A	Gutter Ponding?	N/A	N/A	Gutter Slope (%)	N/A
N/A	Gutter Lip Ht (in)	N/A	N/A	Gutter X Slope (%)	N/A
N/A	Painted X Walk1?	No	N/A	Painted X Walk2?	No
	X Walk 1 Direction	To SE		X Walk 2 Direction	To NE
N/A	X Walk 1 Width (in)	N/A	N/A	X Walk 2 Width (in)	N/A
	X Walk 1 Slope (%)	5.1		X Walk 2 Slope (%)	3.4
	X Walk 1 X Slope (%)	5.6		X Walk 2 X Slope (%)	5.5

N/A	Ramp inside XWalk1?	N/A	N/A	Ramp inside XWalk2?	N/A
	Road Slope (%)	2.2	N/A	Clear Space?	N/A
	Road X Slope (%)	8.0	N/A	Clear Space to XWalk (in)	N/A
N/A	Any Obstructions?	N/A	N/A	Storm Grate/Utility Hazard?	N/A
	Obstruction Type			Storm Grate/Utility Type	
		N/A			N/A
			Yes	Surface Condition? (G/P)	Good

**Remove & Replace Curb Ramp With Two New Directional Ramps or Equivalent.**
