Access Compliance Report

Public Rights-of-Way

(Curb Ramps)

| Intersection ID: 43498 | Main Street: DALTREY_LN | Cross Street: PRESCOTT_HILL_AV | Location: SW |

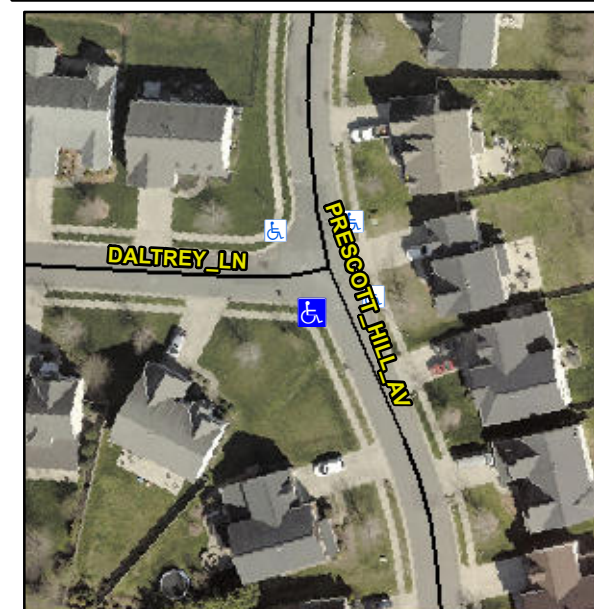
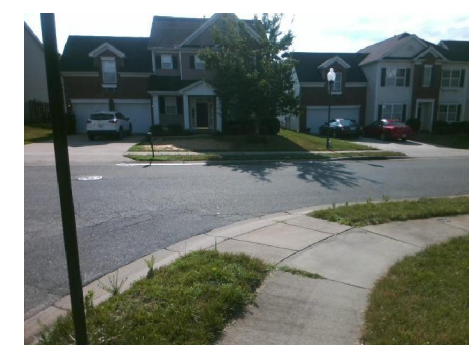
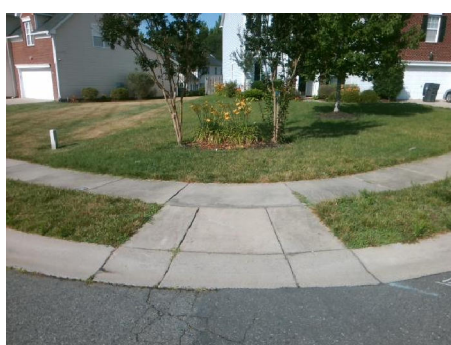
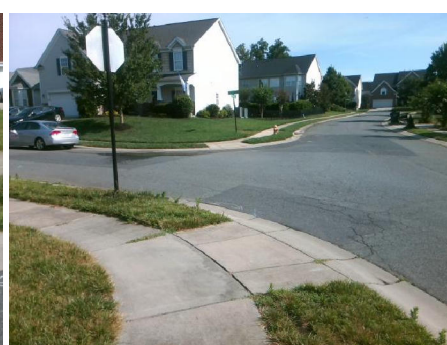
| ADA ID: 0431F4B352E1 | Ramp Type: PerpDiag | Initial Pass/Fail: Fail | Overall Compliance: No |

Not Found, R304.5.1, R304.2.2

| Compliance | Description | Data | Compliance | Description | Data |
|---|---|---|---|---|---|
| N/A | Ramp Length (in) | 48.0 | No | Ramp Slope (%) | 8.6 |
| No | Ramp Width (in) | 38.0 | Yes | Ramp XSlope (%) | 1.4 |

Remove & Replace Curb Ramp With Two New Directional Ramps or Equivalent.
