Access Compliance Report

Public Rights-of-Way

(Curb Ramps)

Intersection ID: 6217	Main Street: BACK_CREEK_CHURCH_RD	Cross Street: WYNDHAM_POINTE_DR	Location: NW
ADA ID: 04334D81CA0E	Ramp Type: Perp	Initial Pass/Fail: Fail	Overall Compliance: No
Codes/Mitigation Info/Possible Solution			Severity Score: 25
			Field Measurements/Component Compliance

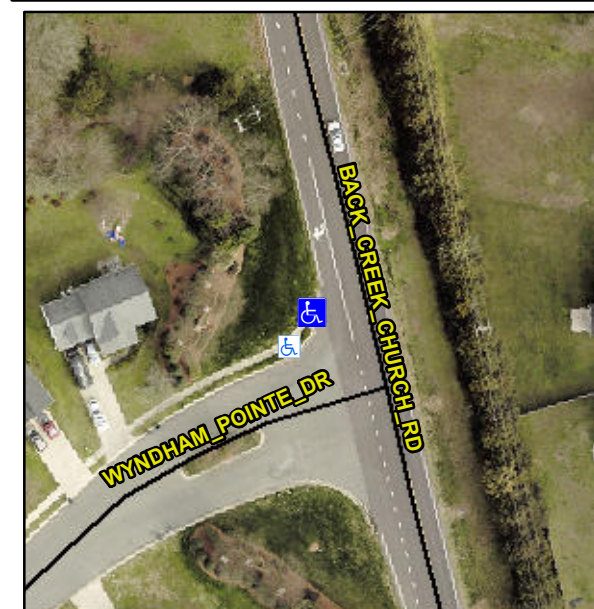
Not Found, R304.2.2, R304.5.3

Compliance	Description	Data	Compliance	Description	Data
N/A	Ramp Length (in)	47.0	No	Ramp Slope (%)	9.9
Yes	Ramp Width (in)	50.0	No	Ramp XSlope (%)	5.3
N/A	Flare Type LT	N/A	N/A	Flare Type RT	N/A
N/A	Flare Slope LT (%)	N/A	N/A	Flare Slope RT (%)	N/A
N/A	Flare Traversable LT?	N/A	N/A	Flare Traversable RT?	N/A
N/A	Landing Length (in)	N/A	N/A	DWS Provided?	N/A
N/A	Landing Width (in)	N/A	N/A	DWS Contrast?	N/A
N/A	Landing Slope (%)	N/A	N/A	DWS Length (in)	N/A
N/A	Landing X Slope (%)	N/A	N/A	DWS Full Width?	N/A
N/A	Landing Curb? (Y/N)	N/A	N/A	DWS Offset (in)	N/A
N/A	Shared Landing?	N/A			
N/A	Gutter Ponding?	N/A	N/A	Gutter Slope (%)	N/A
N/A	Gutter Lip Ht (in)	N/A	N/A	Gutter X Slope (%)	N/A
N/A	Painted X Walk1?	No	N/A	Painted X Walk2?	N/A
	X Walk 1 Direction	To E		X Walk 2 Direction	N/A
N/A	X Walk 1 Width (in)	N/A	N/A	X Walk 2 Width (in)	N/A
	X Walk 1 Slope (%)	7.3		X Walk 2 Slope (%)	N/A
	X Walk 1 X Slope (%)	5.4		X Walk 2 X Slope (%)	N/A

N/A	Ramp inside XWalk1?	N/A	N/A	Ramp inside XWalk2?	N/A
	Road Slope (%)	5.4	N/A	Clear Space?	N/A
	Road X Slope (%)	7.3	N/A	Clear Space to XWalk (in)	N/A
N/A	Any Obstructions?	N/A	N/A	Storm Grate/Utility Hazard?	N/A
	Obstruction Type			Storm Grate/Utility Type	
		N/A			N/A
			Yes	Surface Condition? (G/P)	Good

Remove & Replace Entire Ramp.
