# Access Compliance Report

## Public Rights-of-Way

### (Curb Ramps)

Intersection ID: 11006	Main Street: WESTBROOK_DR	Cross Street: WOODVALE_PL	Location: S
ADA ID: 0436EDC75FC8	Ramp Type: PerpDiag	Initial Pass/Fail: Fail	Overall Compliance: No
Severity Score: 60			
Codes/Mitigation Info/Possible Solution		Field Measurements/Component Compliance

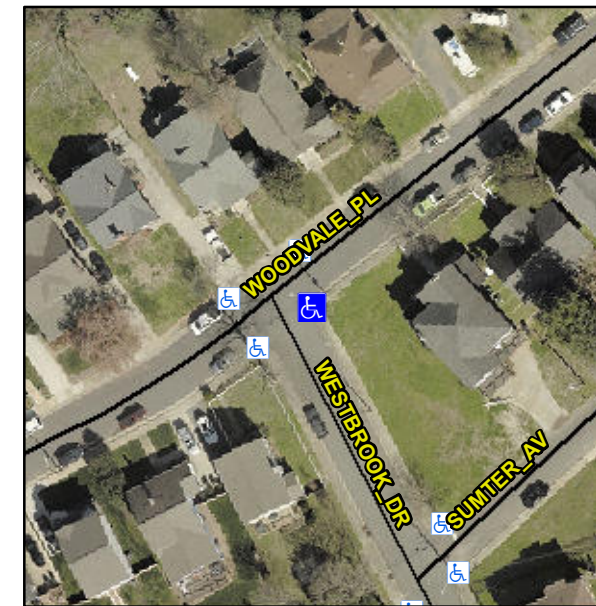
**Not Found, R304.5.1, R304.5.3**

Compliance	Description	Data	Compliance	Description	Data
N/A	Ramp Length (in)	51.0	Yes	Ramp Slope (%)	5.8
No	Ramp Width (in)	26.0	No	Ramp XSlope (%)	12.8
N/A	Flare Type LT	N/A	N/A	Flare Type RT	N/A
N/A	Flare Slope LT (%)	N/A	N/A	Flare Slope RT (%)	N/A
N/A	Flare Traversable LT?	N/A	N/A	Flare Traversable RT?	N/A
N/A	Landing Length (in)	N/A	N/A	DWS Provided?	N/A
N/A	Landing Width (in)	N/A	N/A	DWS Contrast?	N/A
N/A	Landing Slope (%)	N/A	N/A	DWS Length (in)	N/A
N/A	Landing X Slope (%)	N/A	N/A	DWS Full Width?	N/A
N/A	Landing Curb? (Y/N)	N/A	N/A	DWS Offset (in)	N/A
N/A	Shared Landing?	N/A			
N/A	Gutter Ponding?	N/A	N/A	Gutter Slope (%)	N/A
N/A	Gutter Lip Ht (in)	N/A	N/A	Gutter X Slope (%)	N/A
N/A	Painted X Walk1?	No	N/A	Painted X Walk2?	No
	X Walk 1 Direction	To NW		X Walk 2 Direction	To SW
N/A	X Walk 1 Width (in)	N/A	N/A	X Walk 2 Width (in)	N/A
	X Walk 1 Slope (%)	6.4		X Walk 2 Slope (%)	1.6
	X Walk 1 X Slope (%)	5.5		X Walk 2 X Slope (%)	9.6

N/A	Ramp inside XWalk1?	N/A	N/A	Ramp inside XWalk2?	N/A
	Road Slope (%)	6.7	N/A	Clear Space?	N/A
	Road X Slope (%)	8.4	N/A	Clear Space to XWalk (in)	N/A
N/A	Any Obstructions?	N/A	N/A	Storm Grate/Utility Hazard?	N/A
	Obstruction Type			Storm Grate/Utility Type	
		N/A			N/A
			Yes	Surface Condition? (G/P)	Good

**Remove & Replace Curb Ramp With Two New Directional Ramps or Equivalent.**
