## **Access Compliance Report Public Rights-of-Way** (Curb Ramps)

Intersection ID: 17521 Main Street: E WOODLAWN RD **Cross Street: CHASTAIN AV** Location: SE ADA ID: 043739D29838 Ramp Type: Perp Initial Pass/Fail: Fail **Overall Compliance: No Severity Score:** 12.5

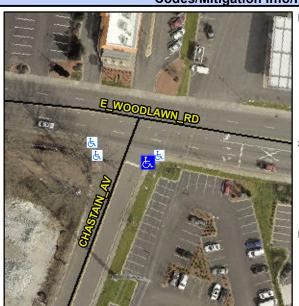
**CHASTAIN AV** Street 1 Name Stop Condition-Street 2 StopSign Street 2 Name N/A Stop Condition-Street 1 N/A Possible Solutions: Remove & Replace Entire Ramp. N/A Yes N/A N/A N/A Surveyor Notes: N/A PROW/ADA: Not Found, R304.2.2

| Compliance Description | | Data | Comp | liance Description | Data |
|---|---|---|---|---|---|
| N/A | Ramp Length (in) | 68.0 | No | Ramp Slope (%) | 10.0 |
| Yes | Ramp Width (in) | 48.0 | Yes | Ramp XSlope (%) | 0.5 |
