# Access Compliance Report

## Public Rights-of-Way

Intersection ID: 19244	Main Street: GLEN_OAKS_RD	Cross Street: SARDIS_RD	Location: S
ADA ID: 043F1B436BB7	Ramp Type: PerpDiag	Initial Pass/Fail: Fail	Overall Compliance: No
Severity Score: 13.75			
Codes/Mitigation Info/Possible Solution		Field Measurements/Component Compliance

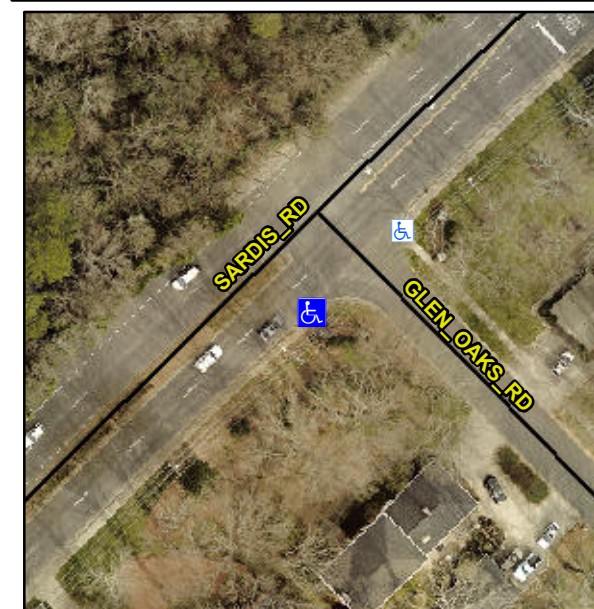
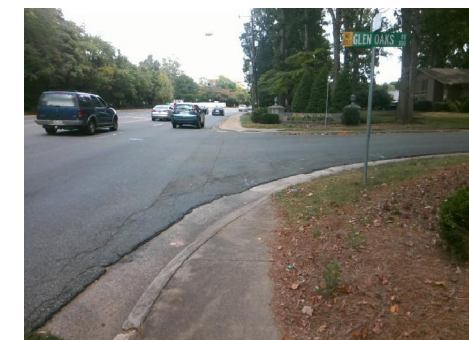
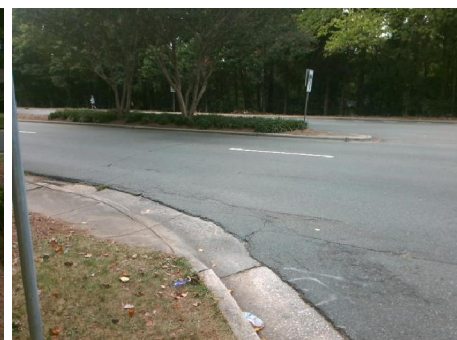
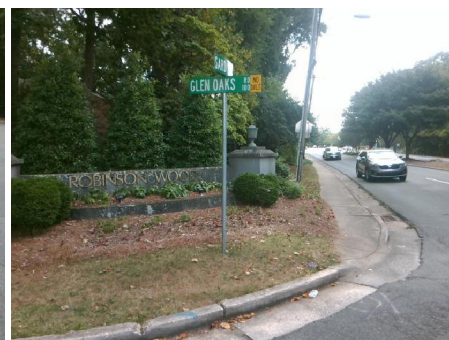
**Not Found, R304.2.2, R304.5.3**

Compliance	Description	Data	Compliance	Description	Data
N/A	Ramp Length (in)	28.0	No	Ramp Slope (%)	10.1
Yes	Ramp Width (in)	48.0	No	Ramp XSlope (%)	3.8
N/A	Flare Type LT	N/A	N/A	Flare Type RT	N/A
N/A	Flare Slope LT (%)	N/A	N/A	Flare Slope RT (%)	N/A
N/A	Flare Traversable LT?	N/A	N/A	Flare Traversable RT?	N/A
N/A	Landing Length (in)	N/A	N/A	DWS Provided?	N/A
N/A	Landing Width (in)	N/A	N/A	DWS Contrast?	N/A
N/A	Landing Slope (%)	N/A	N/A	DWS Length (in)	N/A
N/A	Landing X Slope (%)	N/A	N/A	DWS Full Width?	N/A
N/A	Landing Curb? (Y/N)	N/A	N/A	DWS Offset (in)	N/A
N/A	Shared Landing?	N/A			
N/A	Gutter Ponding?	N/A	N/A	Gutter Slope (%)	N/A
N/A	Gutter Lip Ht (in)	N/A	N/A	Gutter X Slope (%)	N/A
N/A	Painted X Walk1?	No	N/A	Painted X Walk2?	No
	X Walk 1 Direction	To NE		X Walk 2 Direction	To NW
N/A	X Walk 1 Width (in)	N/A	N/A	X Walk 2 Width (in)	N/A
	X Walk 1 Slope (%)	4.8		X Walk 2 Slope (%)	5.3
	X Walk 1 X Slope (%)	1.3		X Walk 2 X Slope (%)	3.6

N/A	Ramp inside XWalk1?	N/A	N/A	Ramp inside XWalk2?	N/A
	Road Slope (%)	3.8	N/A	Clear Space?	N/A
	Road X Slope (%)	5.3	N/A	Clear Space to XWalk (in)	N/A
N/A	Any Obstructions?	N/A	N/A	Storm Grate/Utility Hazard?	N/A
	Obstruction Type			Storm Grate/Utility Type	
		N/A			N/A
		Yes		Surface Condition? (G/P)	Good

**Remove & Replace Curb Ramp With Two New Directional Ramps or Equivalent.**
