Access Compliance Report

Public Rights-of-Way

(Curb Ramps)

Intersection ID: 28409	Main Street: LAUREL_RUN_DR	Cross Street: N/A	Location: S
ADA ID: 044EE392A8F9	Ramp Type: BlendTrans1	Initial Pass/Fail: Pass	Overall Compliance: No
Codes/Mitigation Info/Possible Solution		Field Measurements/Component Compliance	
Severity Score: 10

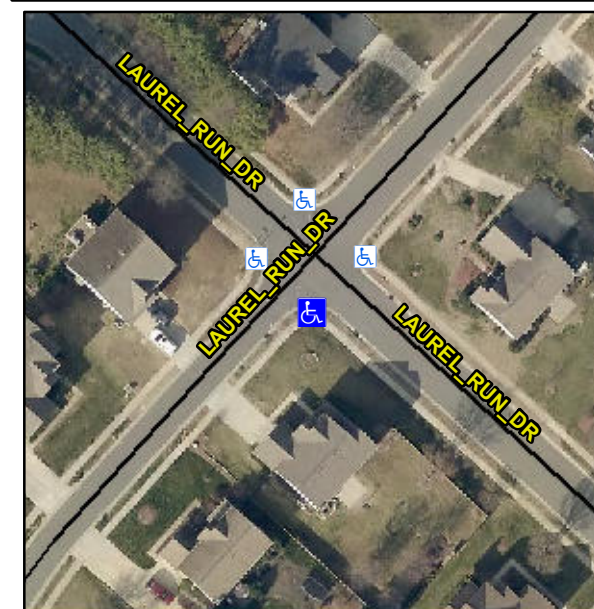
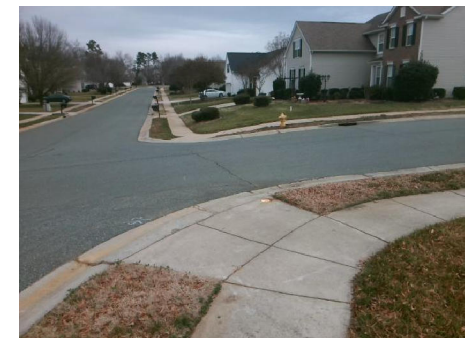
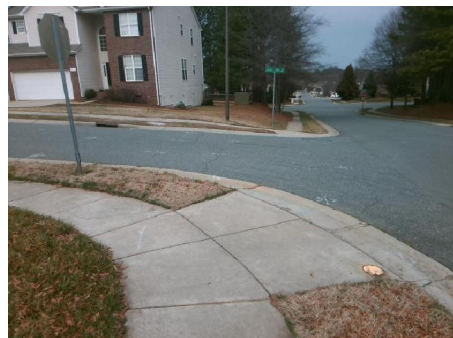
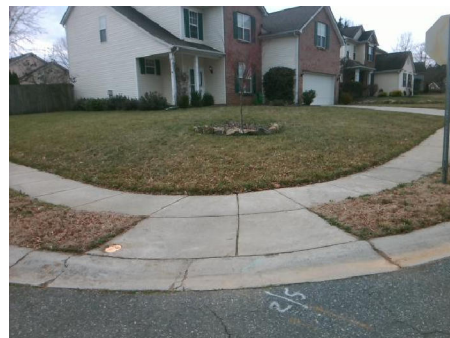
Not Found, R304.2.1, R304.2.2-Perp, R304.3.2-Para, R304.5.3, R305

Compliance	Description	Data	Compliance	Description	Data
N/A	Ramp Length (in)	51.0	Yes	BlendTrans Slope (%)	3.5
Yes	Ramp Width (in)	60.0	Yes	BlendTrans XSlope (%)	0.8
N/A	Flare Type LT	Sloped	N/A	Flare Type RT	Sloped
N/A	Flare Slope LT (%)	4.2	N/A	Flare Slope RT (%)	6.7
N/A	Flare Traversable LT?	No	N/A	Flare Traversable RT?	No
No	Landing Length (in)	44.0	No	DWS Provided?	No
Yes	Landing Width (in)	59.0	N/A	DWS Contrast?	No
No	Landing Slope (%)	5.8	N/A	DWS Length (in)	N/A
No	Landing X Slope (%)	2.5	N/A	DWS Full Width?	No
N/A	Landing Curb? (Y/N)	No	N/A	DWS Offset (in)	N/A
N/A	Shared Landing?	No			
Yes	Gutter Ponding?	No	Yes	Gutter Slope (%)	1.4
Yes	Gutter Lip Ht (in)	0.0	Yes	Gutter X Slope (%)	1.5
N/A	Painted X Walk1?	No	N/A	Painted X Walk2?	No
	X Walk 1 Direction	To NE		X Walk 2 Direction	To NW
	X Walk 1 Width (in)	N/A		X Walk 2 Width (in)	N/A
	X Walk 1 Slope (%)	0.4		X Walk 2 Slope (%)	4.1
	X Walk 1 X Slope (%)	3.8		X Walk 2 X Slope (%)	7.0

N/A	Ramp inside XWalk1?	N/A	N/A	Ramp inside XWalk2?	N/A
	Road Slope (%)	1.9		Clear Space?	Yes
	Road X Slope (%)	8.9	N/A	Clear Space to XWalk (in)	N/A
Yes	Any Obstructions?	No	Yes	Storm Grate/Utility Hazard?	No
	Obstruction Type			Storm Grate/Utility Type	
		N/A			N/A
			Yes	Surface Condition? (G/P)	Good
			No	Curb Slope (%)	5.2

Remove & Replace Curb Ramp With Two New Directional Ramps or Equivalent.
