Access Compliance Report

Public Rights-of-Way

(Curb Ramps)

Intersection ID: 10014519	Main Street: UNIVERSITY_POINTE_BV	Cross Street: N/A	Location: NW
ADA ID: 0451D83CA60D	Ramp Type: Perp	Initial Pass/Fail: Fail	Overall Compliance: No
Severity Score: 10			
Codes/Mitigation Info/Possible Solution		Field Measurements/Component Compliance

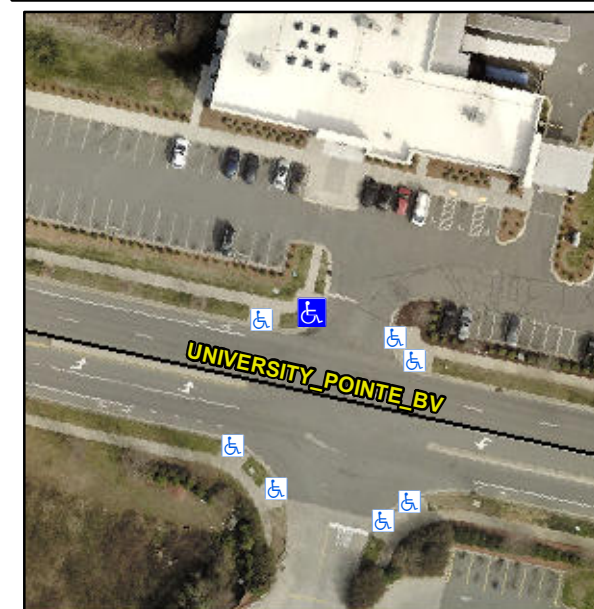
Not Found, R304.5.1, R304.5.3

Compliance	Description	Data	Compliance	Description	Data
N/A	Ramp Length (in)	96.0	Yes	Ramp Slope (%)	6.7
No	Ramp Width (in)	38.0	No	Ramp XSlope (%)	2.8
N/A	Flare Type LT	N/A	N/A	Flare Type RT	N/A
N/A	Flare Slope LT (%)	N/A	N/A	Flare Slope RT (%)	N/A
N/A	Flare Traversable LT?	N/A	N/A	Flare Traversable RT?	N/A
N/A	Landing Length (in)	N/A	N/A	DWS Provided?	N/A
N/A	Landing Width (in)	N/A	N/A	DWS Contrast?	N/A
N/A	Landing Slope (%)	N/A	N/A	DWS Length (in)	N/A
N/A	Landing X Slope (%)	N/A	N/A	DWS Full Width?	N/A
N/A	Landing Curb? (Y/N)	N/A	N/A	DWS Offset (in)	N/A
N/A	Shared Landing?	N/A			
N/A	Gutter Ponding?	N/A	N/A	Gutter Slope (%)	N/A
N/A	Gutter Lip Ht (in)	N/A	N/A	Gutter X Slope (%)	N/A
N/A	Painted X Walk1?	No	N/A	Painted X Walk2?	N/A
	X Walk 1 Direction	To E		X Walk 2 Direction	N/A
N/A	X Walk 1 Width (in)	N/A	N/A	X Walk 2 Width (in)	N/A
	X Walk 1 Slope (%)	3.5		X Walk 2 Slope (%)	N/A
	X Walk 1 X Slope (%)	2.1		X Walk 2 X Slope (%)	N/A

N/A	Ramp inside XWalk1?	N/A	N/A	Ramp inside XWalk2?	N/A
	Road Slope (%)	N/A	N/A	Clear Space?	N/A
	Road X Slope (%)	N/A	N/A	Clear Space to XWalk (in)	N/A
N/A	Any Obstructions?	N/A	N/A	Storm Grate/Utility Hazard?	N/A
	Obstruction Type			Storm Grate/Utility Type	
		N/A			N/A
			Yes	Surface Condition? (G/P)	Good

Possible Solutions:

Remove & Replace Entire Ramp.
