Access Compliance Report Public Rights-of-Way (Curb Ramps)

Intersection ID: 48557 Main Street: RIDGEFOREST DR **Cross Street: ARDREY WOODS DR** Location: SW ADA ID: 0453C651E265 Ramp Type: PerpDiag Initial Pass/Fail: Fail **Overall Compliance: No** Severity Score: 46.25

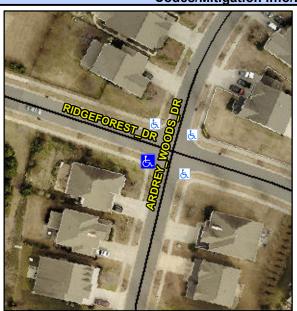
Field Measurements/Component Compliance					
Compliance Description		Data	Comp	oliance Description	Data
N/	A Ramp Length (in)	74.0	No	Ramp Slope (%)	10.2
No	Ramp Width (in)	47.0	No	Ramp XSlope (%)	9.7
N/	A Flare Type LT	N/A	N/A	Flare Type RT	N/A
N/	A Flare Slope LT (%)	N/A	N/A	Flare Slope RT (%)	N/A
N/	A Flare Traversable LT?	N/A	N/A	Flare Traversable RT?	N/A
N/	A Landing Length (in)	N/A	N/A	DWS Provided?	N/A
N/	A Landing Width (in)	N/A	N/A	DWS Contrast?	N/A
N/	A Landing Slope (%)	N/A	N/A	DWS Length (in)	N/A
N/	A Landing X Slope (%)	N/A	N/A	DWS Full Width?	N/A
N/	A Landing Curb? (Y/N)	N/A	N/A	DWS Offset (in)	N/A
N/	A Shared Landing?	N/A			
N/	A Gutter Ponding?	N/A	N/A	Gutter Slope (%)	N/A
N/	A Gutter Lip Ht (in)	N/A	N/A	Gutter X Slope (%)	N/A
N/	A Painted X Walk1?	No	N/A	Painted X Walk2?	No
	X Walk 1 Direction	To SE		X Walk 2 Direction	To NE
N/	A X Walk 1 Width (in)	N/A	N/A	X Walk 2 Width (in)	N/A
	X Walk 1 Slope (%)	1.5		X Walk 2 Slope (%)	3.3

X Walk 1 X Slope (%)	3.3		X Walk 2 X Slope (%)	4.2
N/	A Ramp inside XWalk1?	N/A	N/A	Ramp inside XWalk2?	N/A
	Road Slope (%)	5.7	N/A	Clear Space?	N/A
	Road X Slope (%)	0.7	N/A	Clear Space to XWalk (in)	N/A
N/	A Any Obstructions?	N/A	N/A	Storm Grate/Utility Hazard?	N/A
	Obstruction Type			Storm Grate/Utility Type	
		N/A			N/A
			Yes	Surface Condition? (G/P)	Good
· L

Street 1 Name Stop Condition-Street 2 Street 2 Name Stop Condition-Street 1 ARDREY WOODS DR None RIDGEFOREST DR StopSign Possible Solutions: **Remove & Replace Curb Ramp With** Two New Directional Ramps or Equivalent. Surveyor Notes: N/A PROW/ADA: Not Found, R304.5.1, R304.2.2, R304.5.3

Total Cost: 3200.00
