# Access Compliance Report

## Public Rights-of-Way

### (Curb Ramps)

Intersection ID: 51704	Main Street: IKEA_BV	Cross Street: BROOKSIDE_LN	Location: W
ADA ID: 0462A0AE08E3	Ramp Type: Perp	Initial Pass/Fail: Fail	Overall Compliance: No
		Severity Score: 12.5

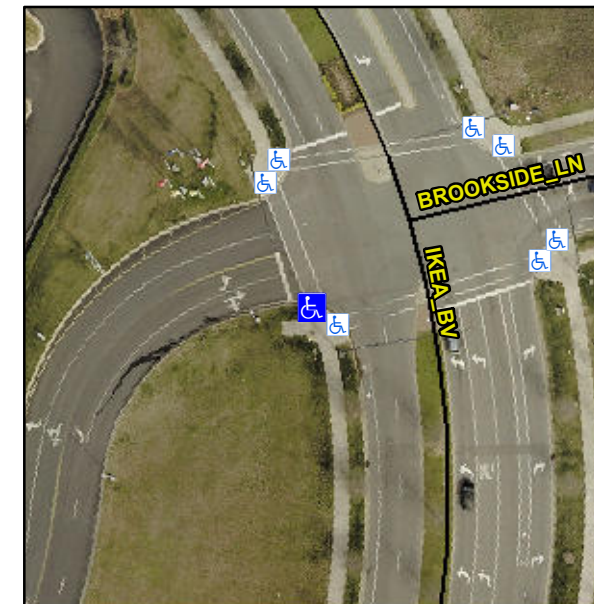
**Not Found, R304.5.3**

Compliance	Description	Data	Compliance	Description	Data
N/A	Ramp Length (in)	94.0	Yes	Ramp Slope (%)	6.3
Yes	Ramp Width (in)	48.0	No	Ramp XSlope (%)	5.1
N/A	Flare Type LT	N/A	N/A	Flare Type RT	N/A
N/A	Flare Slope LT (%)	N/A	N/A	Flare Slope RT (%)	N/A
N/A	Flare Traversable LT?	N/A	N/A	Flare Traversable RT?	N/A
N/A	Landing Length (in)	N/A	N/A	DWS Provided?	N/A
N/A	Landing Width (in)	N/A	N/A	DWS Contrast?	N/A
N/A	Landing Slope (%)	N/A	N/A	DWS Length (in)	N/A
N/A	Landing X Slope (%)	N/A	N/A	DWS Full Width?	N/A
N/A	Landing Curb? (Y/N)	N/A	N/A	DWS Offset (in)	N/A
N/A	Shared Landing?	N/A			
N/A	Gutter Ponding?	N/A	N/A	Gutter Slope (%)	N/A
N/A	Gutter Lip Ht (in)	N/A	N/A	Gutter X Slope (%)	N/A
N/A	Painted X Walk1?	Yes	N/A	Painted X Walk2?	N/A
	X Walk 1 Direction	To N		X Walk 2 Direction	N/A
N/A	X Walk 1 Width (in)	96.0	N/A	X Walk 2 Width (in)	N/A
	X Walk 1 Slope (%)	1.2		X Walk 2 Slope (%)	N/A
	X Walk 1 X Slope (%)	2.3		X Walk 2 X Slope (%)	N/A

N/A	Ramp inside XWalk1?	Yes	N/A	Ramp inside XWalk2?	N/A
	Road Slope (%)	N/A	N/A	Clear Space?	N/A
	Road X Slope (%)	N/A	N/A	Clear Space to XWalk (in)	N/A
N/A	Any Obstructions?	N/A	N/A	Storm Grate/Utility Hazard?	N/A
	Obstruction Type			Storm Grate/Utility Type	
		N/A			N/A
		Yes		Surface Condition? (G/P)	Good

Possible Solutions:

**Remove & Replace Entire Ramp.**
