Access Compliance Report

Public Rights-of-Way

(Curb Ramps)

Intersection ID: 5903	Main Street: MELLWOOD_DR	Cross Street: VALLEYDALE_RD	Location:	N
ADA ID: 0478506B6396	Ramp Type: Perp	Initial Pass/Fail: Fail	Overall Compliance: No	Severity Score: 10
Codes/Mitigation Info/Possible Solution		Field Measurements/Component Compliance

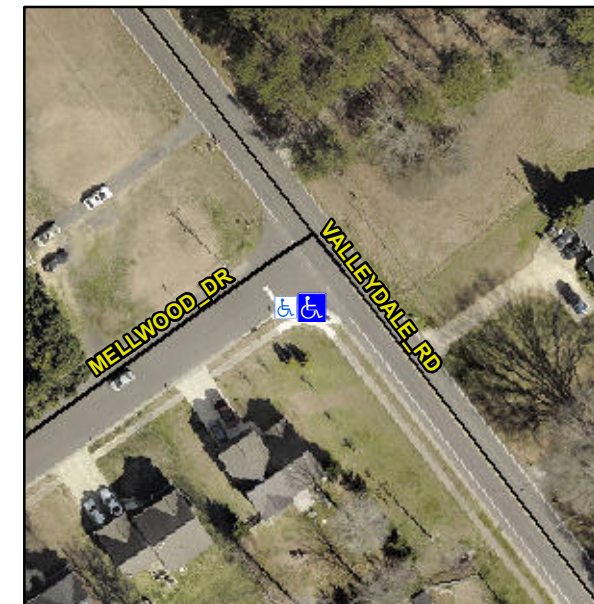
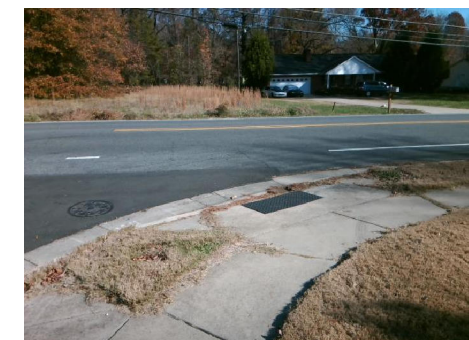
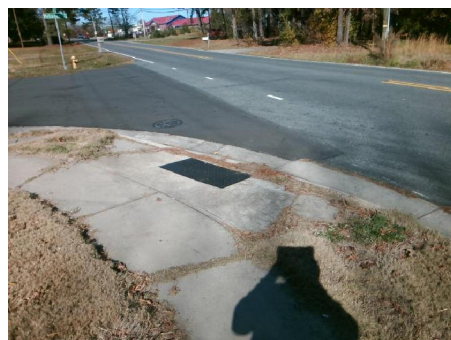
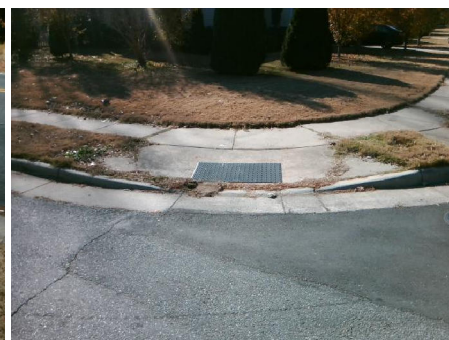
Not Found, R304.5.1, R304.5.3

Compliance	Description	Data	Compliance	Description	Data
N/A	Ramp Length (in)	49.0	Yes	Ramp Slope (%)	6.1
No	Ramp Width (in)	47.0	No	Ramp XSlope (%)	4.0
N/A	Flare Type LT	N/A	N/A	Flare Type RT	N/A
N/A	Flare Slope LT (%)	N/A	N/A	Flare Slope RT (%)	N/A
N/A	Flare Traversable LT?	N/A	N/A	Flare Traversable RT?	N/A
N/A	Landing Length (in)	N/A	N/A	DWS Provided?	N/A
N/A	Landing Width (in)	N/A	N/A	DWS Contrast?	N/A
N/A	Landing Slope (%)	N/A	N/A	DWS Length (in)	N/A
N/A	Landing X Slope (%)	N/A	N/A	DWS Full Width?	N/A
N/A	Landing Curb? (Y/N)	N/A	N/A	DWS Offset (in)	N/A
N/A	Shared Landing?	N/A			
N/A	Gutter Ponding?	N/A	N/A	Gutter Slope (%)	N/A
N/A	Gutter Lip Ht (in)	N/A	N/A	Gutter X Slope (%)	N/A
N/A	Painted X Walk1?	No	N/A	Painted X Walk2?	N/A
	X Walk 1 Direction	To NE		X Walk 2 Direction	N/A
N/A	X Walk 1 Width (in)	N/A	N/A	X Walk 2 Width (in)	N/A
	X Walk 1 Slope (%)	9.9		X Walk 2 Slope (%)	N/A
	X Walk 1 X Slope (%)	2.8		X Walk 2 X Slope (%)	N/A

N/A	Ramp inside XWalk1?	N/A	N/A	Ramp inside XWalk2?	N/A
	Road Slope (%)	2.8	N/A	Clear Space?	N/A
	Road X Slope (%)	9.9	N/A	Clear Space to XWalk (in)	N/A
N/A	Any Obstructions?	N/A	N/A	Storm Grate/Utility Hazard?	N/A
	Obstruction Type			Storm Grate/Utility Type	
		N/A			N/A
			Yes	Surface Condition? (G/P)	Good

Possible Solutions:

Remove & Replace Entire Ramp.
