Access Compliance Report

Public Rights-of-Way

(Curb Ramps)

Intersection ID: 18173	Main Street: COLONY_RD	Cross Street: PICARDY_PL	Location: NE
ADA ID: 047D83A77B76	Ramp Type: PerpDiag	Initial Pass/Fail: Fail	Overall Compliance: No
Severity Score: 13.75			
Codes/Mitigation Info/Possible Solution		Field Measurements/Component Compliance

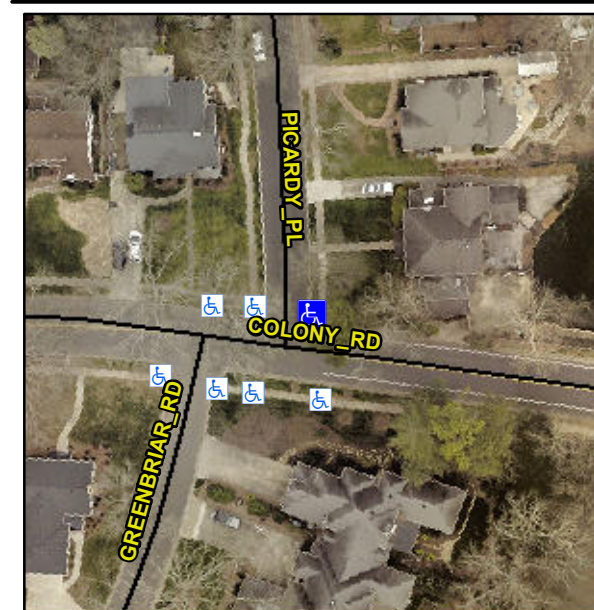
R304.2.2, R304.5.3

Compliance	Description	Data	Compliance	Description	Data
N/A	Ramp Length (in)	82.0	No	Ramp Slope (%)	9.6
Yes	Ramp Width (in)	48.0	No	Ramp XSlope (%)	4.5
N/A	Flare Type LT	N/A	N/A	Flare Type RT	N/A
N/A	Flare Slope LT (%)	N/A	N/A	Flare Slope RT (%)	N/A
N/A	Flare Traversable LT?	N/A	N/A	Flare Traversable RT?	N/A
N/A	Landing Length (in)	N/A	N/A	DWS Provided?	N/A
N/A	Landing Width (in)	N/A	N/A	DWS Contrast?	N/A
N/A	Landing Slope (%)	N/A	N/A	DWS Length (in)	N/A
N/A	Landing X Slope (%)	N/A	N/A	DWS Full Width?	N/A
N/A	Landing Curb? (Y/N)	N/A	N/A	DWS Offset (in)	N/A
N/A	Shared Landing?	N/A			
N/A	Gutter Ponding?	N/A	N/A	Gutter Slope (%)	N/A
N/A	Gutter Lip Ht (in)	N/A	N/A	Gutter X Slope (%)	N/A
N/A	Painted X Walk1?	No	N/A	Painted X Walk2?	No
	X Walk 1 Direction	To NW		X Walk 2 Direction	To S
N/A	X Walk 1 Width (in)	N/A	N/A	X Walk 2 Width (in)	N/A
	X Walk 1 Slope (%)	5.3		X Walk 2 Slope (%)	3.3
	X Walk 1 X Slope (%)	2.0		X Walk 2 X Slope (%)	4.1

N/A	Ramp inside XWalk1?	N/A	N/A	Ramp inside XWalk2?	N/A
	Road Slope (%)	3.0	N/A	Clear Space?	N/A
	Road X Slope (%)	1.9	N/A	Clear Space to XWalk (in)	N/A
N/A	Any Obstructions?	N/A	N/A	Storm Grate/Utility Hazard?	N/A
	Obstruction Type			Storm Grate/Utility Type	
		N/A			N/A
		Yes		Surface Condition? (G/P)	Good

Possible Solutions:

Remove & Replace Curb Ramp With Two New Directional Ramps or Equivalent.
