Access Compliance Report

Public Rights-of-Way

(Curb Ramps)

Intersection ID: 2457	Main Street: CAMBELLTON_DR	Cross Street: CLARKE_CREEK_PY	Location: N
ADA ID: 048578999850	Ramp Type: PerpDiag	Initial Pass/Fail: Fail	Overall Compliance: No
Codes/Mitigation Info/Possible Solution		Field Measurements/Component Compliance	
Severity Score: 21.25

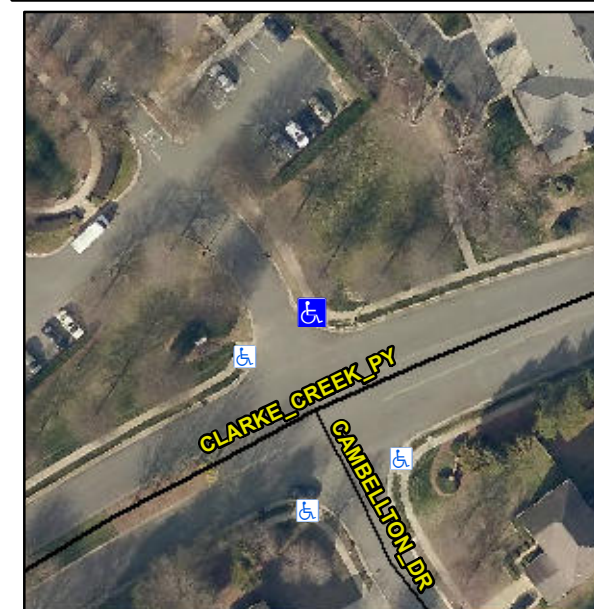
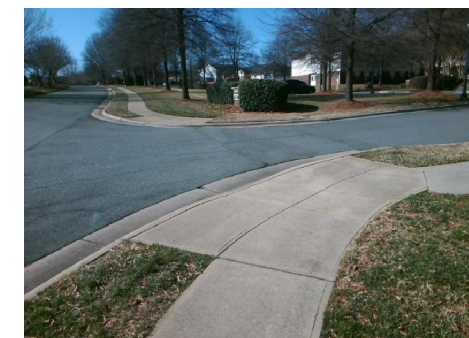
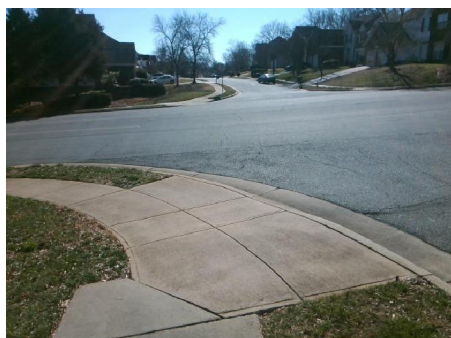
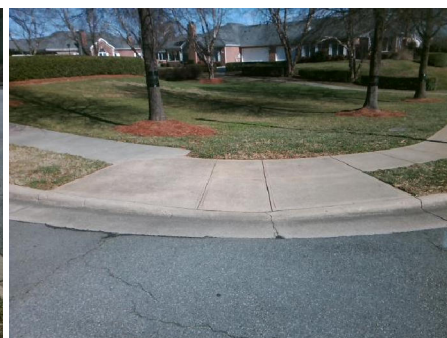
Not Found, R304.5.1, R304.5.3

Compliance	Description	Data	Compliance	Description	Data
N/A	Ramp Length (in)	48.0	Yes	Ramp Slope (%)	5.2
No	Ramp Width (in)	38.0	No	Ramp XSlope (%)	6.2
N/A	Flare Type LT	N/A	N/A	Flare Type RT	N/A
N/A	Flare Slope LT (%)	N/A	N/A	Flare Slope RT (%)	N/A
N/A	Flare Traversable LT?	N/A	N/A	Flare Traversable RT?	N/A
N/A	Landing Length (in)	N/A	N/A	DWS Provided?	N/A
N/A	Landing Width (in)	N/A	N/A	DWS Contrast?	N/A
N/A	Landing Slope (%)	N/A	N/A	DWS Length (in)	N/A
N/A	Landing X Slope (%)	N/A	N/A	DWS Full Width?	N/A
N/A	Landing Curb? (Y/N)	N/A	N/A	DWS Offset (in)	N/A
N/A	Shared Landing?	N/A			
N/A	Gutter Ponding?	N/A	N/A	Gutter Slope (%)	N/A
N/A	Gutter Lip Ht (in)	N/A	N/A	Gutter X Slope (%)	N/A
N/A	Painted X Walk1?	No	N/A	Painted X Walk2?	No
	X Walk 1 Direction	To SW		X Walk 2 Direction	To SE
N/A	X Walk 1 Width (in)	N/A	N/A	X Walk 2 Width (in)	N/A
	X Walk 1 Slope (%)	5.1		X Walk 2 Slope (%)	0.2
	X Walk 1 X Slope (%)	3.9		X Walk 2 X Slope (%)	7.8

N/A	Ramp inside XWalk1?	N/A	N/A	Ramp inside XWalk2?	N/A
	Road Slope (%)	5.1	N/A	Clear Space?	N/A
	Road X Slope (%)	5.6	N/A	Clear Space to XWalk (in)	N/A
N/A	Any Obstructions?	N/A	N/A	Storm Grate/Utility Hazard?	N/A
	Obstruction Type			Storm Grate/Utility Type	
		N/A			N/A
			Yes	Surface Condition? (G/P)	Good

Possible Solutions:

Remove & Replace Curb Ramp With Two New Directional Ramps or Equivalent.
