Access Compliance Report

Public Rights-of-Way

(Curb Ramps)

Intersection ID: 17220	Main Street: GRAYLING_CT	Cross Street: WALNUT_WOOD_DR	Location: NE
ADA ID: 0496AC8D103D	Ramp Type: PerpDiag	Initial Pass/Fail: Fail	Overall Compliance: No
			Severity Score: 13.75

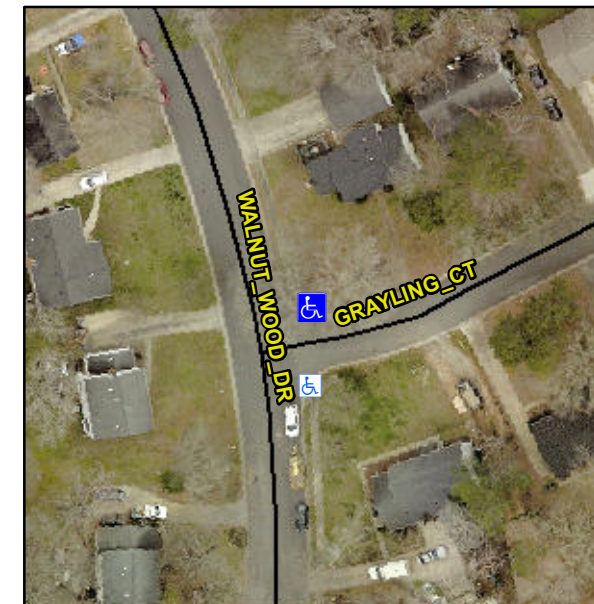
Not Found, R304.2.2, R304.5.3

Compliance	Description	Data	Compliance	Description	Data
N/A	Ramp Length (in)	80.0	No	Ramp Slope (%)	9.6
Yes	Ramp Width (in)	66.0	No	Ramp XSlope (%)	2.5
N/A	Flare Type LT	N/A	N/A	Flare Type RT	N/A
N/A	Flare Slope LT (%)	N/A	N/A	Flare Slope RT (%)	N/A
N/A	Flare Traversable LT?	N/A	N/A	Flare Traversable RT?	N/A
N/A	Landing Length (in)	N/A	N/A	DWS Provided?	N/A
N/A	Landing Width (in)	N/A	N/A	DWS Contrast?	N/A
N/A	Landing Slope (%)	N/A	N/A	DWS Length (in)	N/A
N/A	Landing X Slope (%)	N/A	N/A	DWS Full Width?	N/A
N/A	Landing Curb? (Y/N)	N/A	N/A	DWS Offset (in)	N/A
N/A	Shared Landing?	N/A			
N/A	Gutter Ponding?	N/A	N/A	Gutter Slope (%)	N/A
N/A	Gutter Lip Ht (in)	N/A	N/A	Gutter X Slope (%)	N/A
N/A	Painted X Walk1?	No	N/A	Painted X Walk2?	No
	X Walk 1 Direction	To W		X Walk 2 Direction	To SW
N/A	X Walk 1 Width (in)	N/A	N/A	X Walk 2 Width (in)	N/A
	X Walk 1 Slope (%)	1.0		X Walk 2 Slope (%)	2.0
	X Walk 1 X Slope (%)	3.8		X Walk 2 X Slope (%)	3.1

N/A	Ramp inside XWalk1?	N/A	N/A	Ramp inside XWalk2?	N/A
	Road Slope (%)	2.6	N/A	Clear Space?	N/A
	Road X Slope (%)	2.1	N/A	Clear Space to XWalk (in)	N/A
N/A	Any Obstructions?	N/A	N/A	Storm Grate/Utility Hazard?	N/A
	Obstruction Type			Storm Grate/Utility Type	
		N/A			N/A
			Yes	Surface Condition? (G/P)	Good

Remove & Replace Curb Ramp With Two New Directional Ramps or Equivalent.
